## FIELD INSPECTION REPORT

<b>Project Name:</b>	Mountain Valley Pipeline	<b>Inspector:</b>	Marshall Willis
<b>Inspection Date:</b>	Thursday, April 22, 2021	<b>Project Contact:</b>	Brian Clauto, Cory Chalmers
<b>Spread G: Giles County</b>	STA 11150+00 – 11158+12 STA 11298+29 – 11254+88 MVP-GI-253.02	<b>Weather:</b>	Dry

## FIELD INSPECTION PHOTO LOG

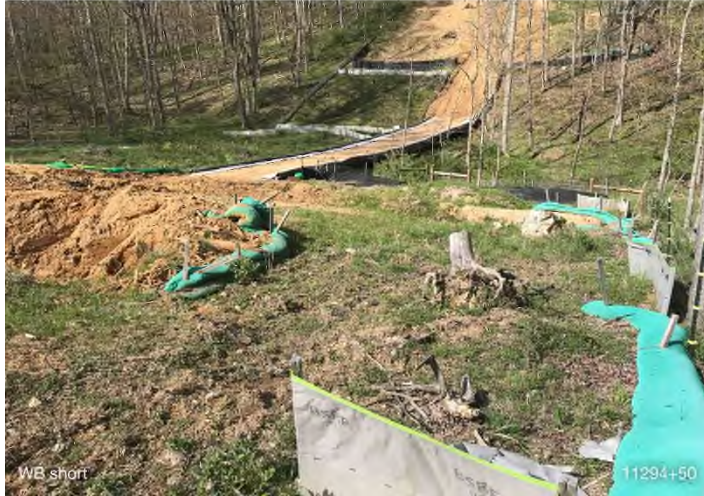
**Figure 1: STA 11294+50** – Waterbar does not extend full width of ROW.

**Recommended Corrective Action:** Maintain and install all controls per the approved PSS&S.

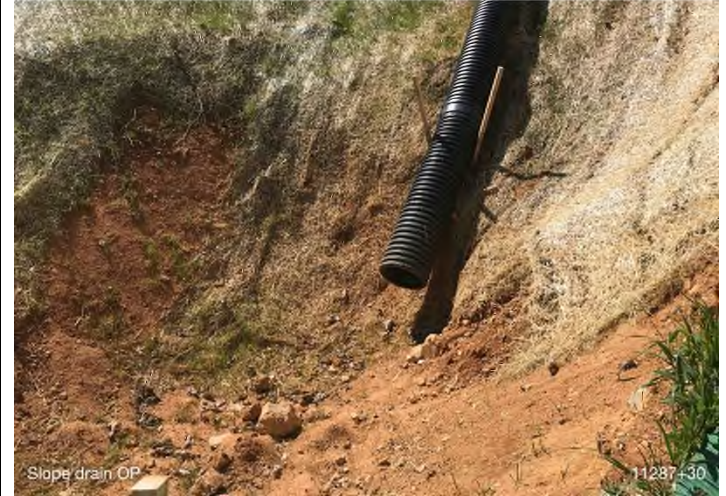
**Figure 2: STA 11287+30** – Slope drain does not have outlet protection.

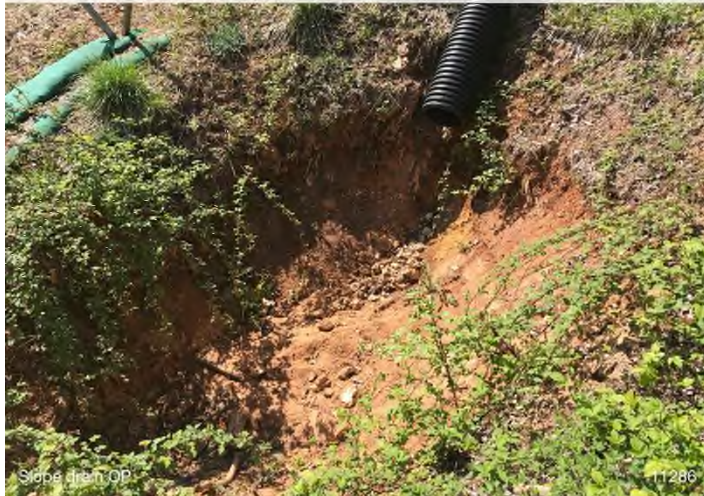
**Figure 3: STA 11286+00** – Slope drain does not have outlet protection.

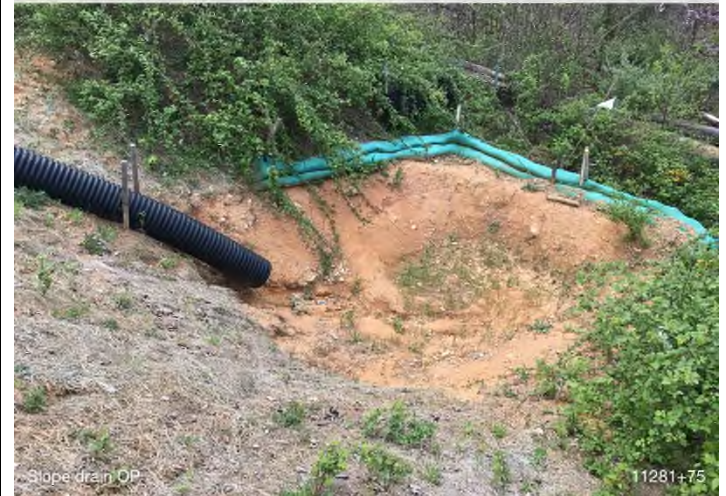
**Figure 4: STA 11281+75** – Slope drain does not have outlet protection.

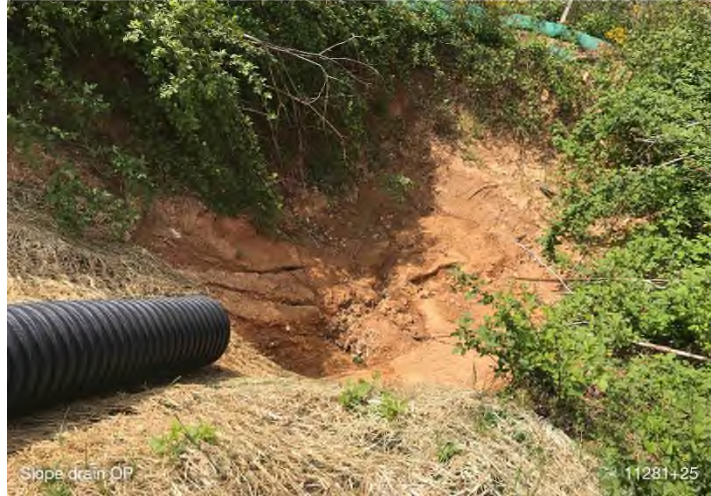
**Figure 5: STA 11281+25** – Slope drain does not have outlet protection.  
 BRG: 122°SE (T) LAT: 37.295792 LON: -80.485271 ±16ft ALT: 2273ft

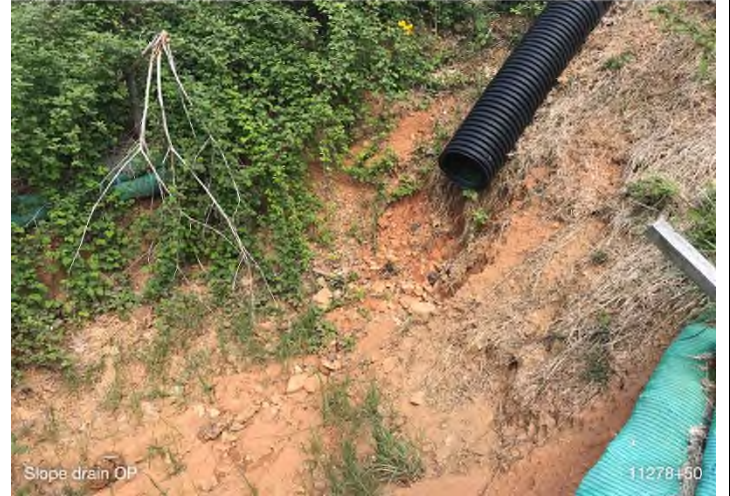
**Figure 6: STA 11278+50** – Slope drain does not have outlet protection.  
 BRG: 321°NW (T) LAT: 37.295762 LON: -80.486173 ±16ft ALT: 2241ft

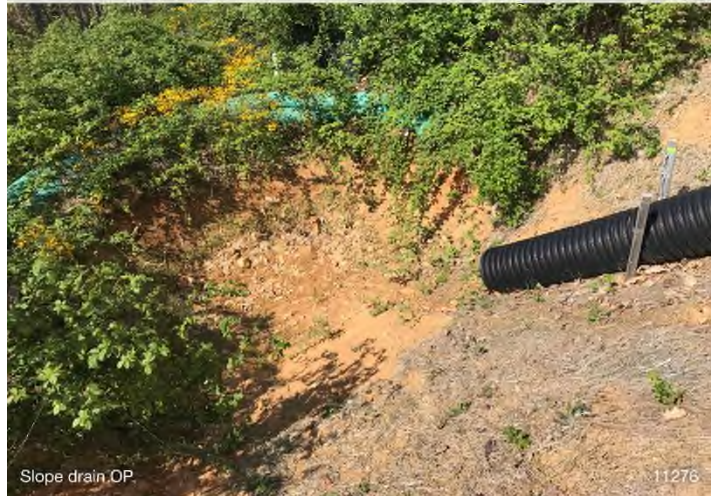
**Figure 7: STA 11276+00** – Slope drain does not have outlet protection.  
 BRG: 241°SW (T) LAT: 37.295868 LON: -80.487126 ±16ft ALT: 2281ft

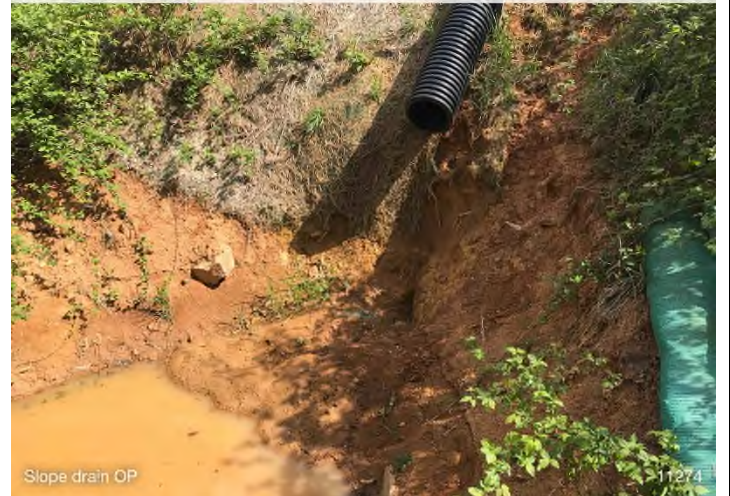
**Figure 8: STA 11274+00** – Slope drain does not have outlet protection.  
 BRG: 11°N (T) LAT: 37.295878 LON: -80.487701 ±32ft ALT: 2263ft

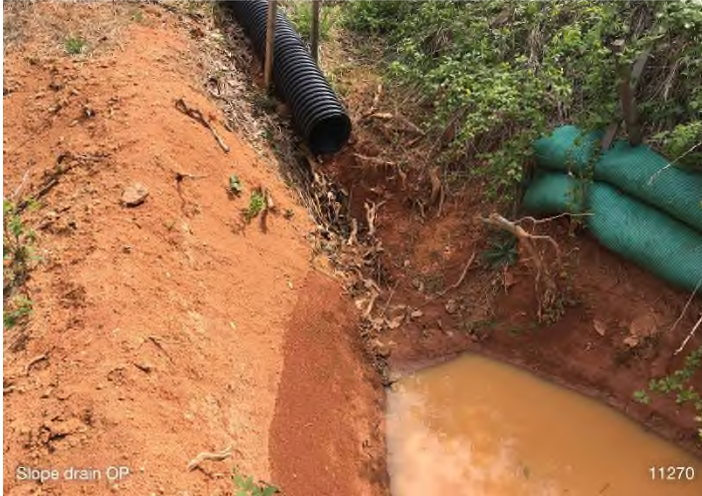
**Figure 9: STA 11270+50** – Slope drain does not have outlet protection.
