FIELD INSPECTION REPORT

Project Name:	Mountain Valley Pipeline	Inspector:	Marshall Willis
Inspection Date:	Tuesday, April 13, 2021	Project Contact:	Brian Clauto, Cory Chalmers
Spread G: Craig County Giles County	STA 11353+67 – 11524+16 MVP-CR-258.02 MVP-GI-256	Weather:	Dry

FIELD INSPECTION PHOTO LOG

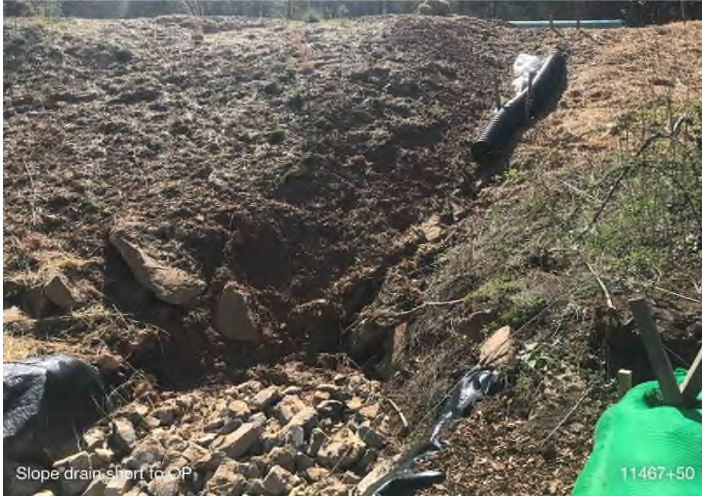
- STA 11467+50: Slope drain improper installation. Discharges onto fill slope.
- STA 11409+50: Waterbar end-treatment improper installation. CFS outlet higher than waterbar.

Figure 1: STA 11467+50 – Slope drain improper installation. Discharge down fill slope.

Recommended Corrective Action: Maintain and install all controls per the approved PSS&S.

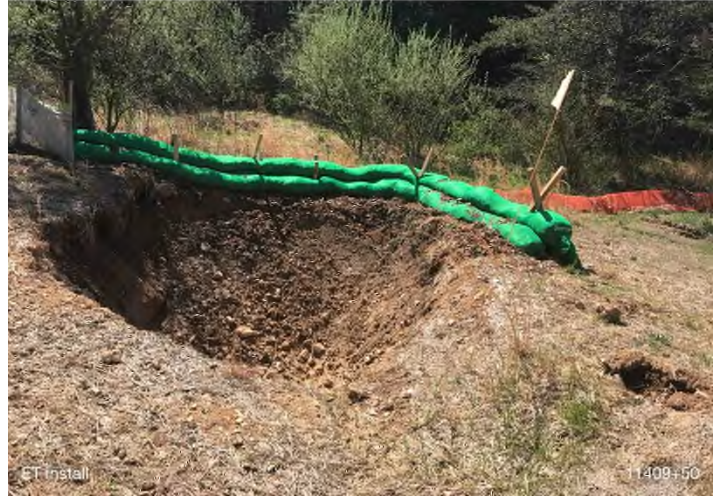
Figure 2: STA 11409+50 – Waterbar end-treatment improper installation. CFS outlet higher than waterbar.

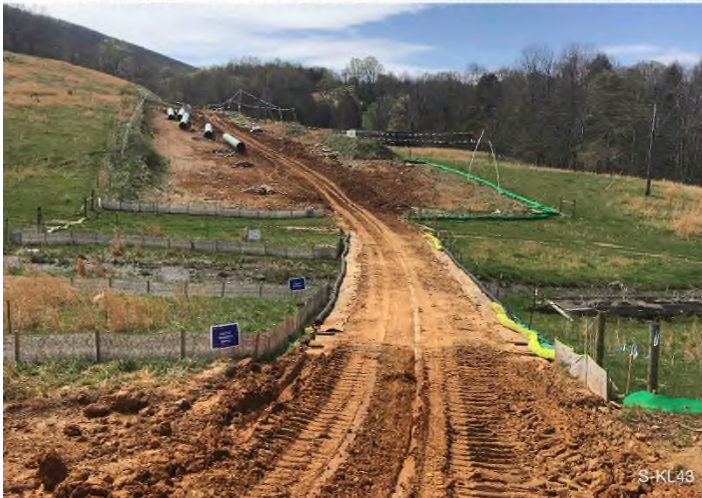
Figure 3: Stream S-KL43 – Controls in place and functioning properly.

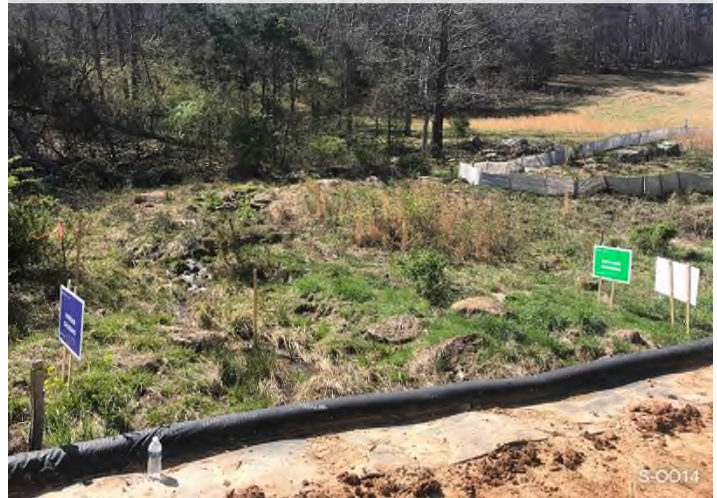
Figure 4: Stream S-0014 – Controls in place and functioning properly.
