FIELD INSPECTION REPORT

Project Name:	Mountain Valley Pipeline	Inspector:	Marshall Willis
Inspection Date:	Friday, June 11, 2021	Project Contact:	Brian Clauto, Cory Chalmers
Spread G: Giles County	STA 10929+71 – 11023+80 MVP-GI-244	Weather:	Wet

FIELD INSPECTION PHOTO LOG

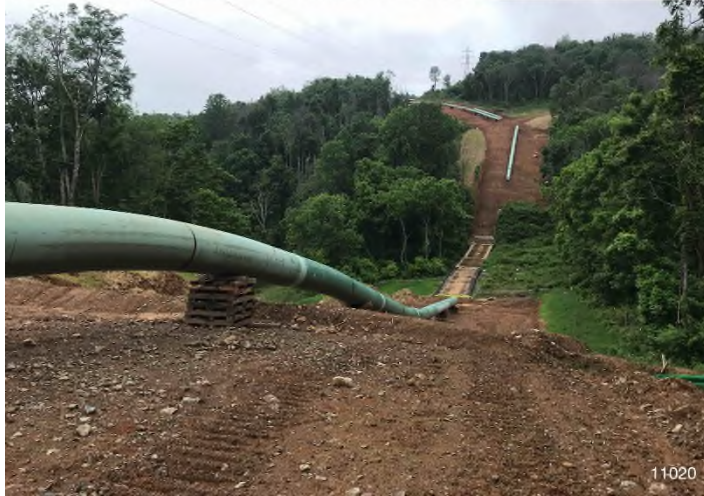
Figure 1: STA 11020+00 – Controls in place and functioning properly.
 BRG: 281°W (T) LAT: 37.323307 LON: -80.554028 ±16ft ALT: 2458ft

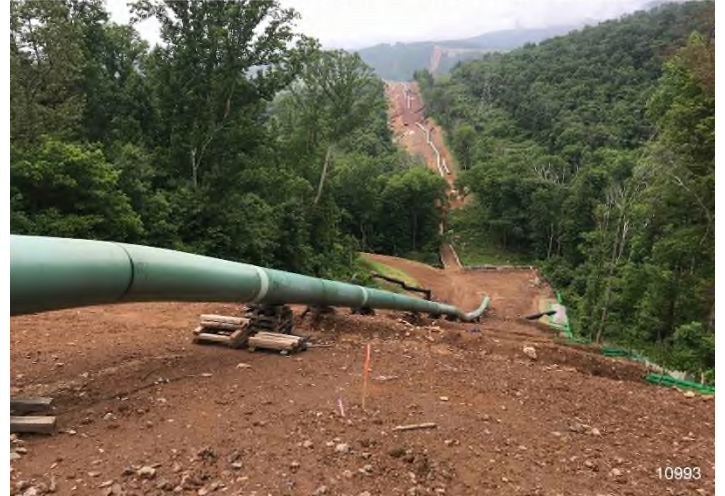
Figure 2: STA 10993+00 – Controls in place and functioning properly.
 BRG: 311°NW (T) LAT: 37.324776 LON: -80.562949 ±16ft ALT: 2587ft

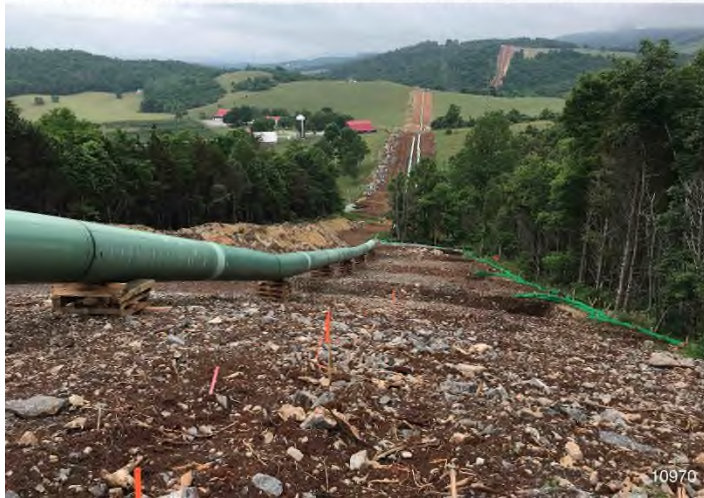
Figure 3: STA 10970+00 – Controls in place and functioning properly.
 BRG: 277°W (T) LAT: 37.327311 LON: -80.570350 ±16ft ALT: 2433ft

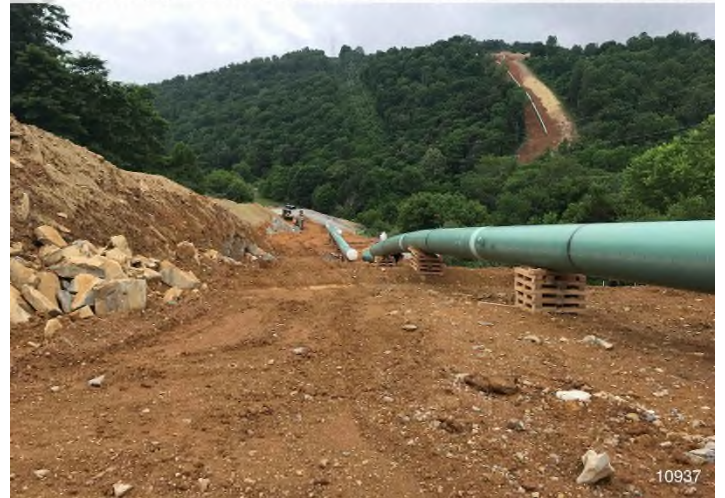
Figure 4: STA 10937+00 – Controls in place and functioning properly.
 BRG: 291°W (T) LAT: 37.330321 LON: -80.580914 ±16ft ALT: 2283ft
