# FIELD INSPECTION REPORT

<b>Project Name:</b>	Mountain Valley Pipeline	<b>Inspector:</b>	Matthew Grant
<b>Inspection Date:</b>	Wednesday, June 9, 2021	<b>Project Contact:</b>	Brian Clauto
<b>Spread G: Giles</b>	AR 258.02, 258.01, GI 249.01 ATWS 1347, 1370, 1370A, 1464 St 11530-11472 St 11226-11170	<b>Weather:</b>	Dry

# FIELD INSPECTION PHOTO LOG

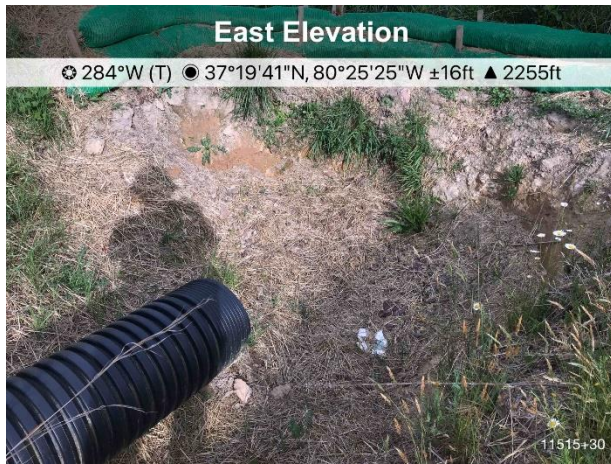
- St 11515+30 sump lacks stone

Figure 1: St 11515+30 sump lacks stone.

**Recommended Corrective Action:** Maintain and install all controls per the approved PSS&S.

**Deadline:** Within 24-Hour of Notification

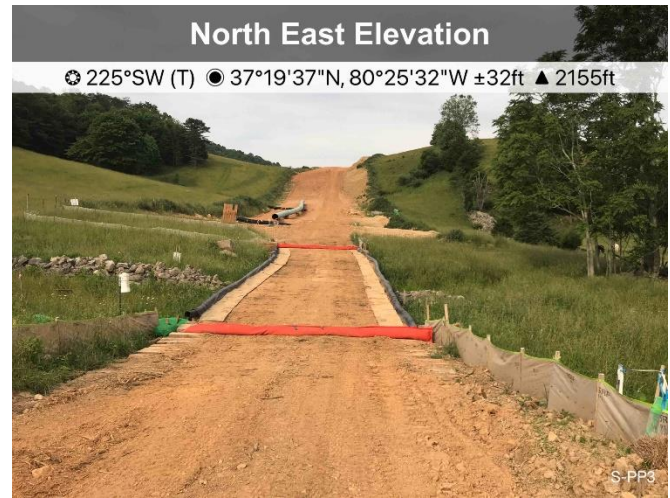
Figure 2: Designated crossing S-PP3, ECD's are in place.

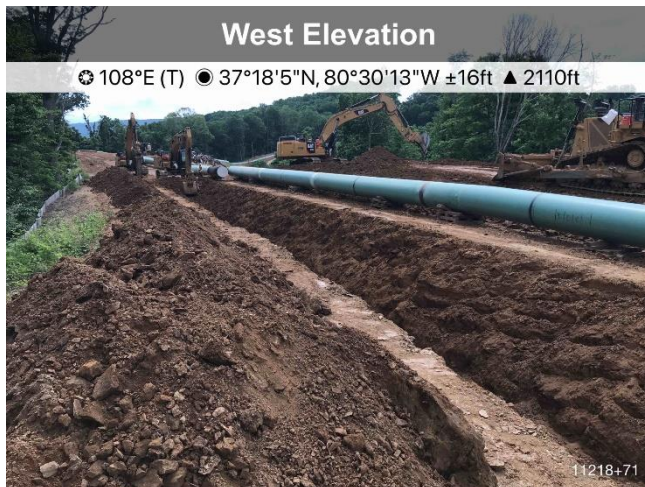
Figure 3: St11218+71 active trenching

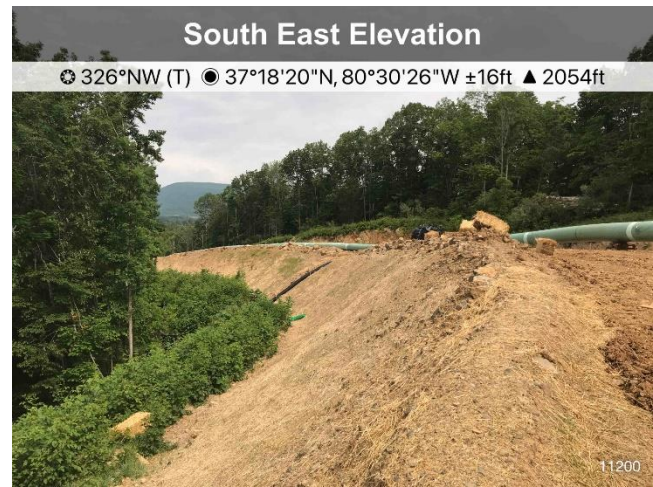
Figure 4: St 11200 stabilized slope
