COMPLAINT INVESTIGATION REPORT

Project Name:	Mountain Valley Pipeline	Inspector:	Marshall Willis, John McCutcheon
Inspection Date:	Wednesday, June 9, 2021	Project Contact:	Brian Clauto, Cory Chalmers
Spread I: Franklin County	STA 13892+45 – 13915+52	Weather:	Dry

FIELD INSPECTION PHOTO LOG

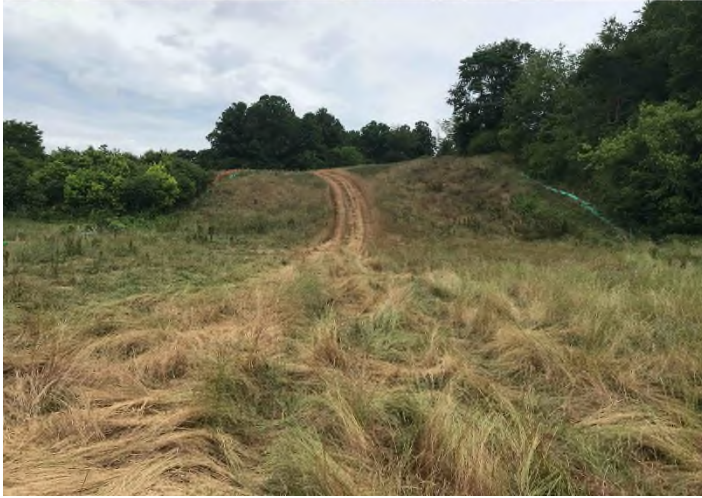
3. ROW in this area is currently stabilized with permanent and temporary vegetative cover and no significant erosion was evident within the LOD (Figure 1).

Figure 1: STA 13900+00 – Controls in place and functioning properly. ROW stabilized with vegetation.

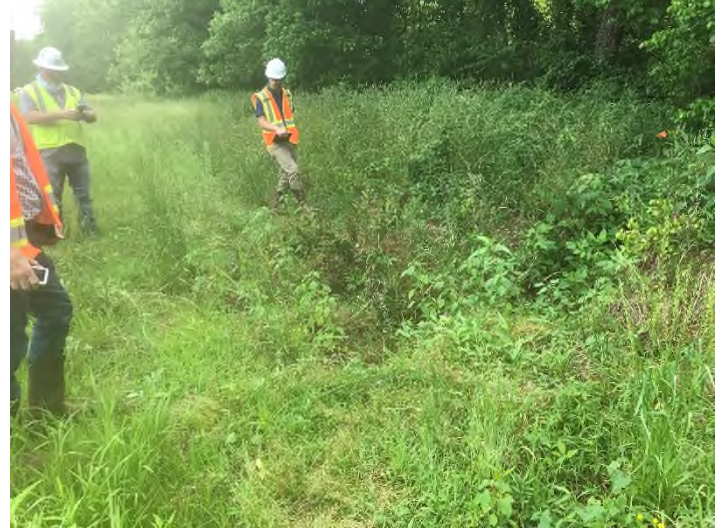
5. Causation of the "sinkholes" south of the ROW along the banks of Little Creek was unable to be determined but was likely caused from streambank overflow from both the Blackwater River and Little Creek exiting the floodplain and returning into the stream channel in high flow conditions (Figure 2).

Figure 2: OFF ROW – “Sinkhole” or bank scour along Little Creek near confluence of Blackwater River. Likely the cause of overbank flow re-entering the stream channel from the floodplain.

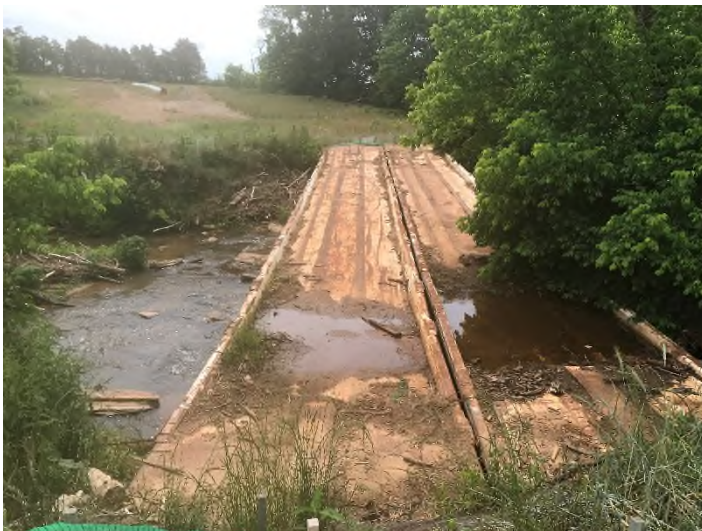
Figure 3: Stream S-II2 (Little Creek) – MVP temporary equipment crossing. Bridge does not impede normal flow conditions.

4. West side of MVP temporary equipment bridge has sunk slightly overtime as a result of several significant storm flows where the banks of Little Creek were overtopped, spilling into the floodplain (Figure 4). MVP has notified the ACOE of this issue and because the area is stable, the bridge is not impeding normal flow conditions and current removal risks exposure to additional erosion, MVP has elected to monitor the condition and remove any woody debris that may become lodged at the crossing (Figure 3).

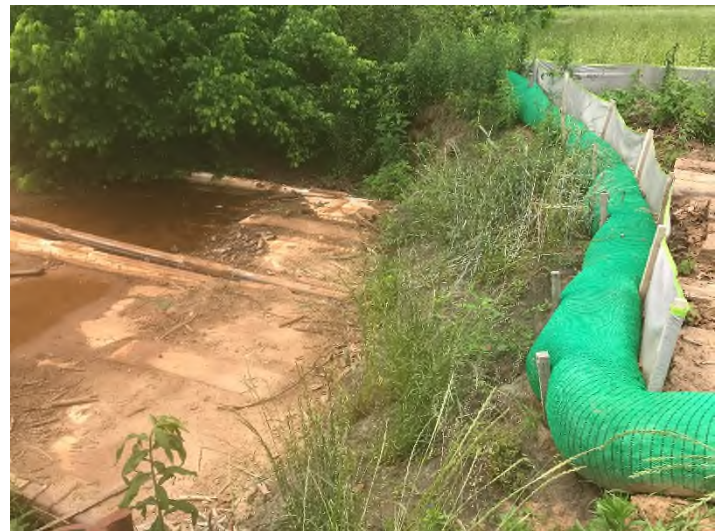
Figure 4: Stream S-II2 (Little Creek) – West site of equipment crossing bridge has sunk slightly from several repeated flood conditions.
