Project Name:	Mountain Valley Pipeline	Inspector:	Matthew Grant
Inspection Date:	Thursday, May 27, 2021	Project Contact:	Brian Clauto
Spread G: Giles	AR GI 240, 258.04 ATWS 1057, 1373 St10690-10660 St11620-11600	Weather:	Dry

## FIELD INSPECTION PHOTO LOG

Project Name: Mountain Valley Pipeline <u>Date</u>: Thursday, May 27, 2021

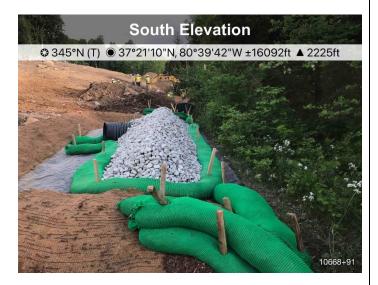
Figure 1: Installation of ECD at St10688+91.

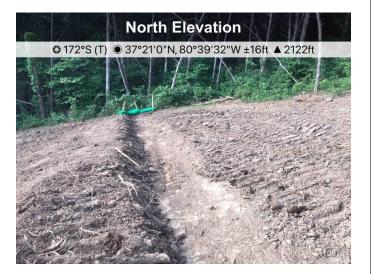
Figure 2: Installation of temporary waterbar at St10676.

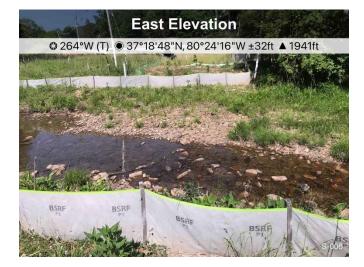
Figure 4: Designated crossing S-006, ECD's are in place.
