FIELD INSPECTION REPORT

Project Name:	Mountain Valley Pipeline	Inspector:	Marshall Willis
Inspection Date:	Tuesday, May 18, 2021	Project Contact:	Brian Clauto, Cory Chalmers
Spread G: Montgomery County	STA 11596+94 - 11618+91 MVP-MN-258.05	Weather:	Wet

FIELD INSPECTION PHOTO LOG

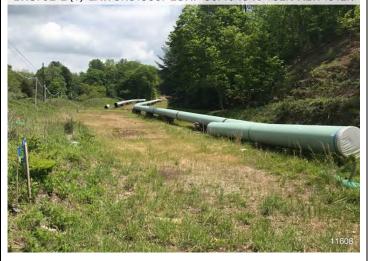
<u>Figure 3</u>: **STA 11608+00** – Controls in place and functioning properly.
