Project Name:	Mountain Valley Pipeline	Inspector:	Matthew Grant
Inspection Date:	Tuesday, May 18, 2021	Project Contact:	Brian Clauto
Spread G: Giles	AR GI 234 ATWS 1129 Yard 28	Weather:	Dry

FIELD INSPECTION PHOTO LOG

<u>Project Name</u>: Mountain Valley Pipeline <u>Date</u>: Tuesday, May 18, 2021

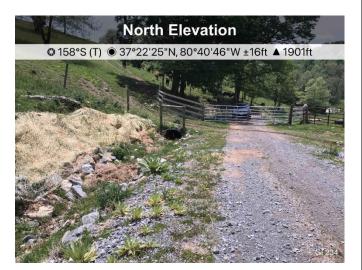
Figure 1: Access road GI 234 matting remains installed.

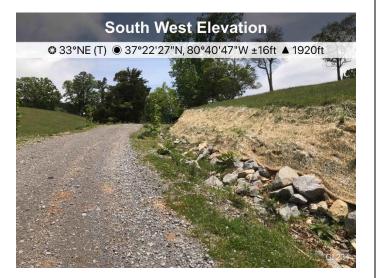
Figure 2: Access road GI 234 matting remains installed.
