FIELD INSPECTION REPORT

Project Name:	Mountain Valley Pipeline	Inspector:	Marshall Willis
Inspection Date:	Monday, May 17, 2021	Project Contact:	Brian Clauto, Cory Chalmers
Spread G: Giles County	STA 10749+71 – 10789+05 MVP-GI-241.01/241.04/241.03	Weather:	Rainy

FIELD INSPECTION PHOTO LOG

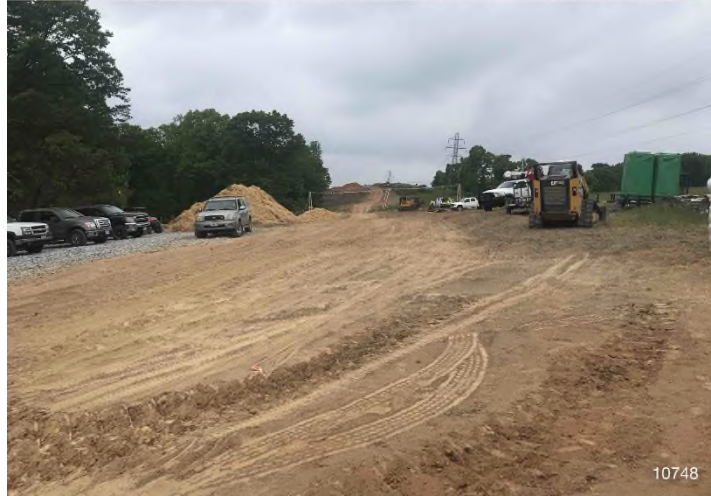
Figure 1: STA 10748+00 – Controls in place and functioning properly.
BRG: 321°NW (T) **LAT:** 37.345255 **LON:** -80.636571 ±16ft **ALT:** 2301ft

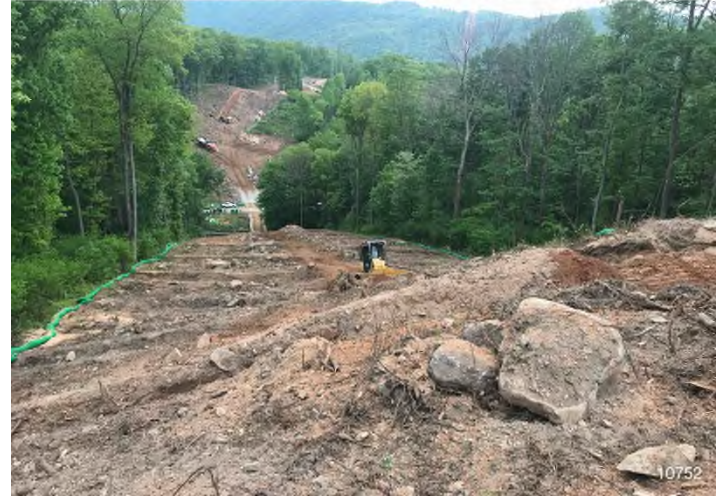
Figure 2: STA 10752+00 – Controls in place and functioning properly.
BRG: 92°E (T) **LAT:** 37.344586 **LON:** -80.635579 ±16ft **ALT:** 2285ft

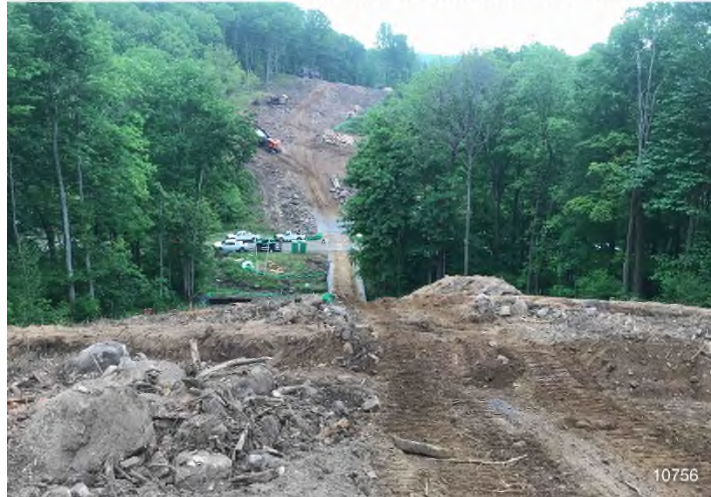
Figure 3: STA 10756+00 – Controls in place and functioning properly.
BRG: 85°E (T) **LAT:** 37.344733 **LON:** -80.634306 ±16ft **ALT:** 2211ft

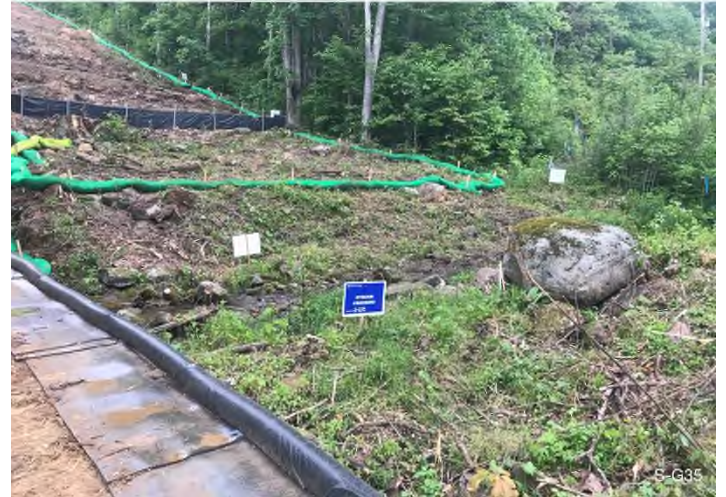
Figure 4: Stream S-G35 – Controls in place and functioning properly.
BRG: 303°NW (T) **LAT:** 37.344790 **LON:** -80.633358 ±32ft **ALT:** 2124ft
