## FIELD INSPECTION REPORT

<b>Project Name:</b>	Mountain Valley Pipeline	<b>Inspector:</b>	Marshall Willis
<b>Inspection Date:</b>	Tuesday, May 11, 2021	<b>Project Contact:</b>	Brian Clauto, Cory Chalmers
<b>Spread G: Giles County</b>	STA 10674+92 – 10707+00 MVP-GI-241/241.01/241.03/241.04	<b>Weather:</b>	Dry

## FIELD INSPECTION PHOTO LOG

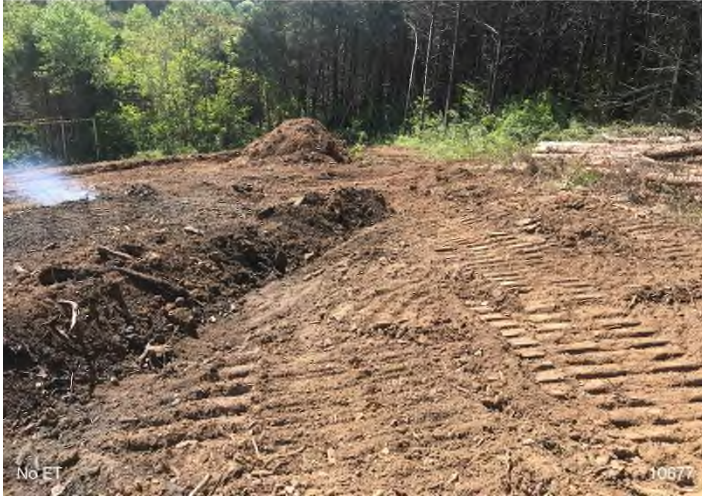
**Figure 1: STA 10677+00** – Topsoil waterbar does not have end-treatment.

**Recommended Corrective Action:** Maintain and install all controls per the approved PSS&S.

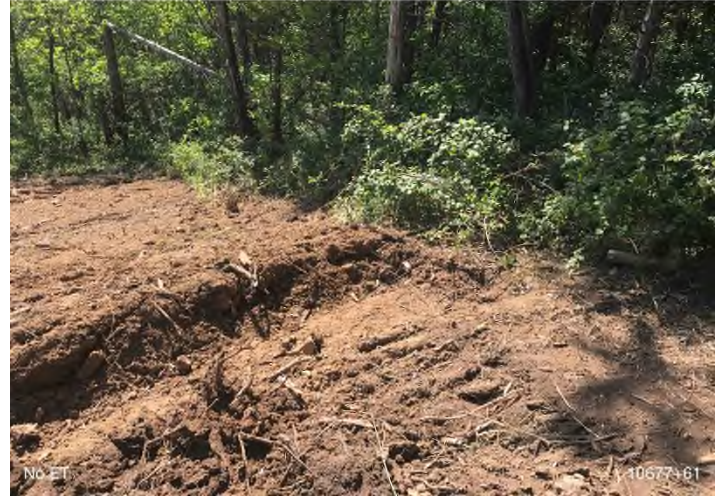
**Figure 2: STA 10677+61** – Topsoil waterbar does not have end-treatment.

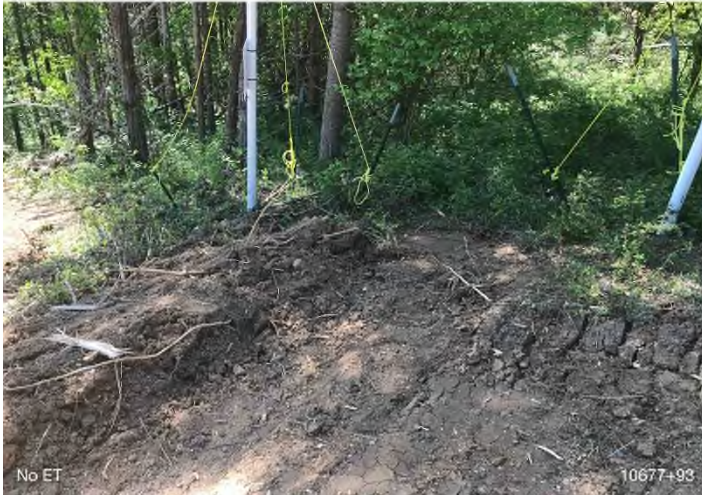
**Figure 3: STA 10677+93** – Topsoil waterbar does not have end-treatment.

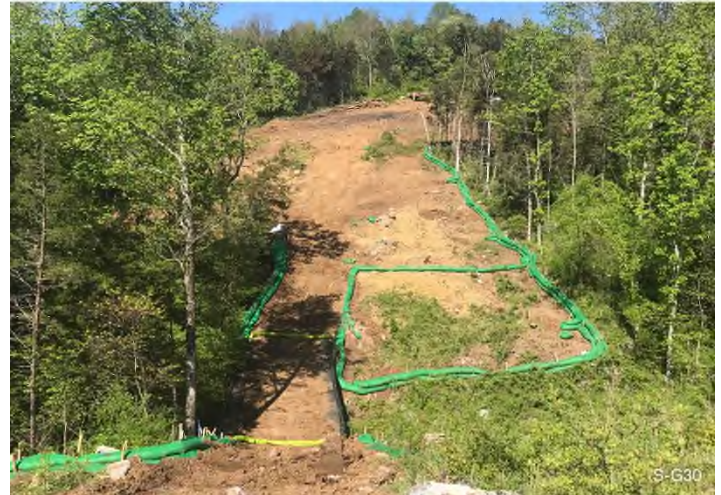
**Figure 4: Stream S-G30** – Controls in place and functioning properly.
