FIELD INSPECTION REPORT

Project Name:	Mountain Valley Pipeline	Inspector:	Marshall Willis
Inspection Date:	Wednesday, May 5, 2021	Project Contact:	Brian Clauto, Cory Chalmers
Spread G: Craig County	STA 11524+16 – 11471+52 MVP-CR-258.02 MVP-CR-258.01	Weather:	Wet

FIELD INSPECTION PHOTO LOG

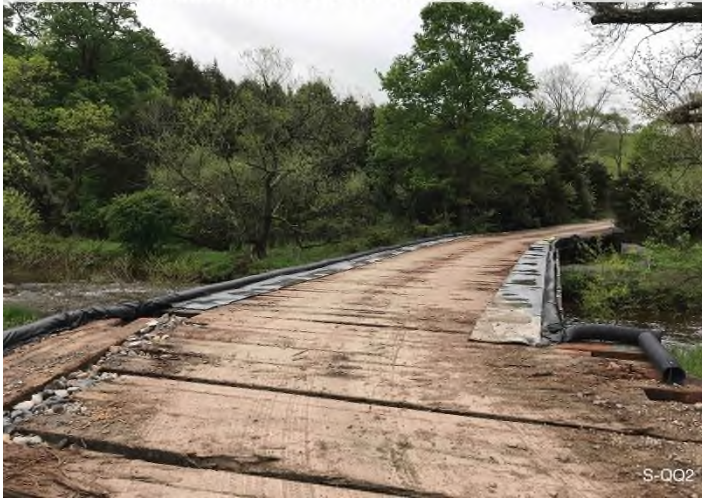
Figure 1: Stream S-QQ2 – Controls in place and functioning properly around stream crossing. (Sinking Creek)
BRG: 178°S (T) **LAT:** 37.333126 **LON:** -80.431150 ±541ft **ALT:** 2008ft

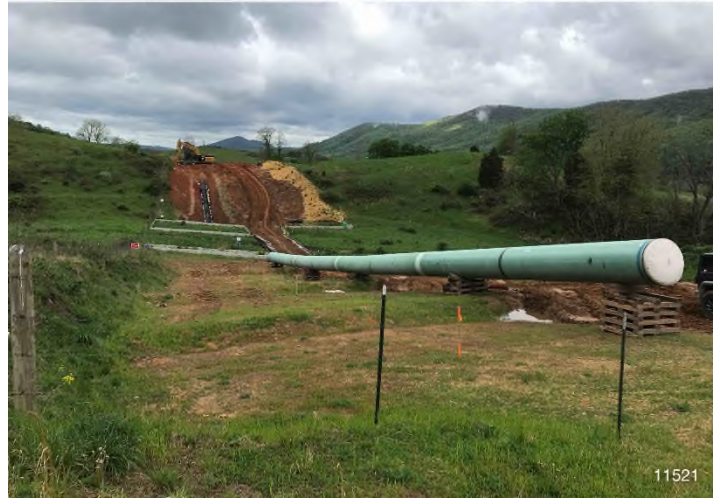
Figure 2: STA 11521+00 – Controls in place and functioning properly.
BRG: 263°W (T) **LAT:** 37.328683 **LON:** -80.421833 ±16ft **ALT:** 2248ft

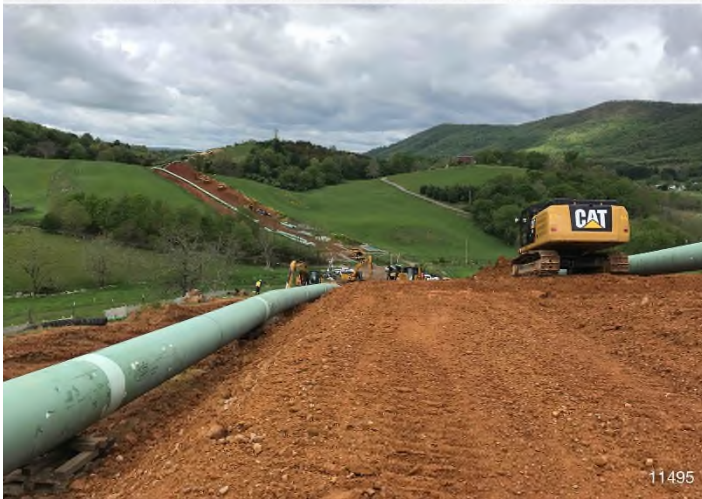
Figure 3: STA 11495+00 – Controls in place and functioning properly.
BRG: 230°SW (T) **LAT:** 37.325289 **LON:** -80.429496 ±16ft **ALT:** 2288ft

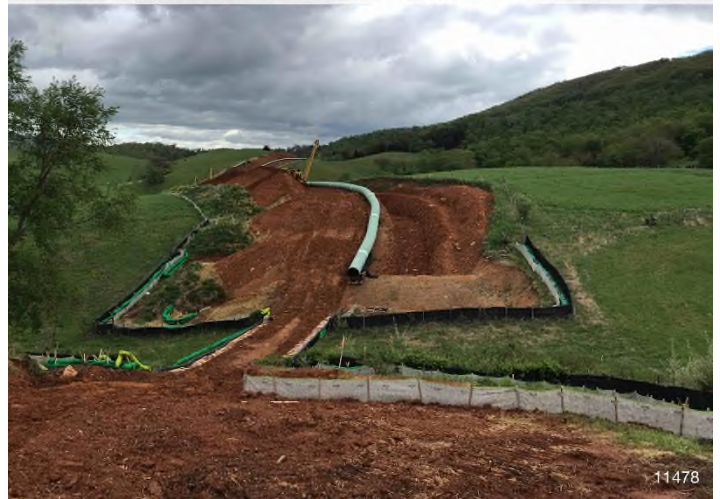
Figure 4: STA 11478+00 – Controls in place and functioning properly.
BRG: 65°NE (T) **LAT:** 37.280701 **LON:** -80.388092 ±6562ft **ALT:** 2148ft
