Project Name:	Mountain Valley Pipeline	Inspector:	Matthew Grant		
Inspection Date:	Tuesday, April 27, 2021	Project Contact:	Brian Clauto		
Spread G: Giles	ST11300-11353+60 10970-11062 ATWS 633A, 633 AR 253.02, 242.01	Weather:	Dry

FIELD INSPECTION PHOTO LOG

Project Name: Mountain Valley Pipeline <u>Date</u>: Tuesday, April 27, 2021

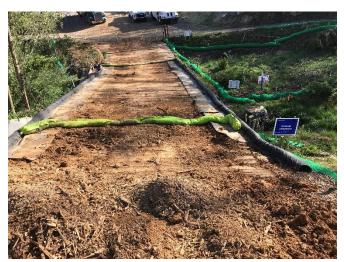
Figure 2: Designated crossing S-NN11, ECD's are in place.

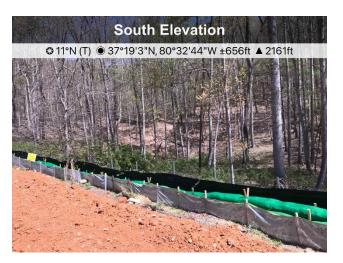
Figure 3: Near St11056 the karsts area is protected by ECD's.
