Project Name:	Mountain Valley Pipeline	Inspector:	Matthew Grant
Inspection Date:	Monday, April 26, 2021	Project Contact:	Brian Clauto
Spread G: Giles	ST11254+66-11168 ATWS 1347, 1464 AR MLV 25, GI 249.01	Weather:	Dry

FIELD INSPECTION PHOTO LOG

Project Name: Mountain Valley Pipeline Date: Monday, April 26, 2021

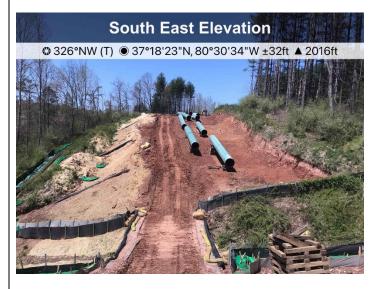
Figure 3: Near St11190, pipe has been strung and ECD's are in place for active construction.

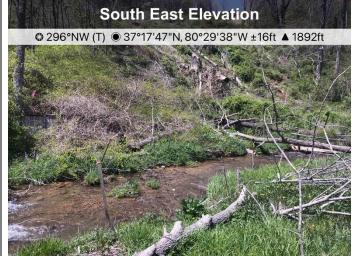
<u>Figure 4</u>: Designated crossing S-YZ6 &W-RR1b, fell trees remain in place.
