FIELD INSPECTION REPORT

Project Name:	Mountain Valley Pipeline	Inspector:	Marshall Willis
Inspection Date:	Friday, June 25, 2021	Project Contact:	Brian Clauto, Cory Chalmers
Spread G: Giles County	STA 10656+80 – 10675+00 STA 10749+41 – 10774+15 MVP-GI-240	Weather:	Dry

FIELD INSPECTION PHOTO LOG

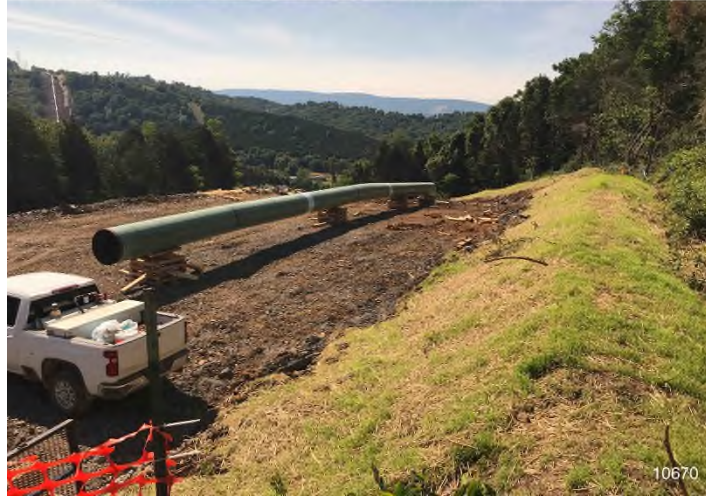
Figure 1: STA 10670+00 – Controls in place and functioning properly.
 BRG: 142°SE (T) LAT: 37.351245 LON: -80.660704 ±16ft ALT: 2256ft

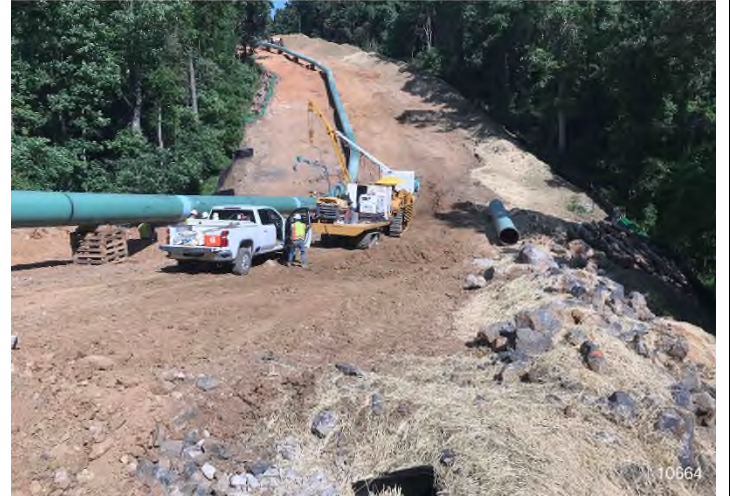
Figure 2: STA 10664+00 – Controls in place and functioning properly.
 BRG: 307°NW (T) LAT: 37.352778 LON: -80.661354 ±16ft ALT: 2203ft

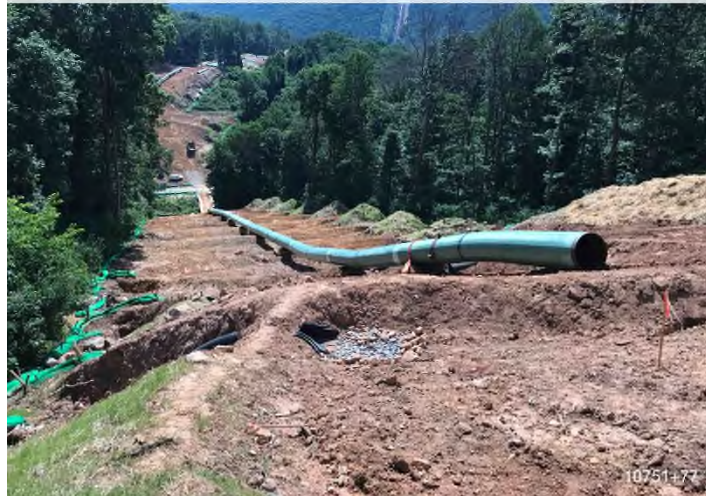
Figure 3: STA 10751+77 – Controls in place and functioning properly.
 BRG: 102°E (T) LAT: 37.344677 LON: -80.635558 ±98ft ALT: 2229ft

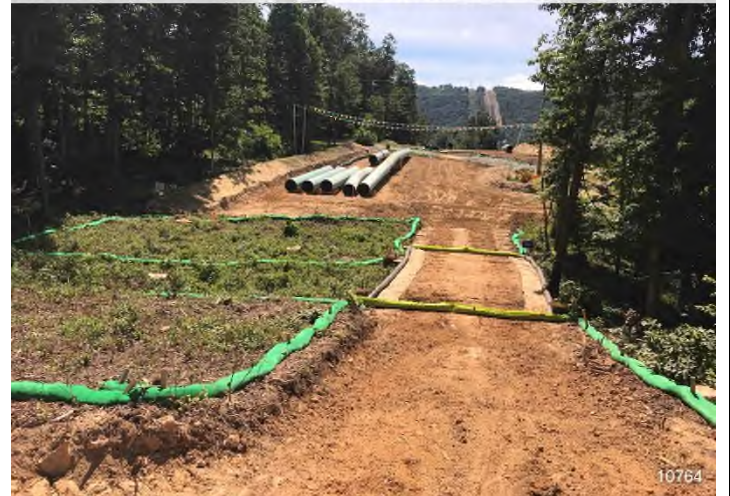
Figure 4: STA 10764+00 – Controls in place and functioning properly.
 BRG: 80°E (T) LAT: 37.343719 LON: -80.632378 ±1384ft ALT: 2078ft
