FIELD INSPECTION REPORT

Project Name:	Mountain Valley Pipeline	Inspector:	Marshall Willis
Inspection Date:	Monday, June 6, 2022	Project Contact:	Brian Clauto, Cory Chalmers
Spread G: Giles County	STA 10859+34 – 10929+71	Weather:	Dry

FIELD INSPECTION PHOTO LOG

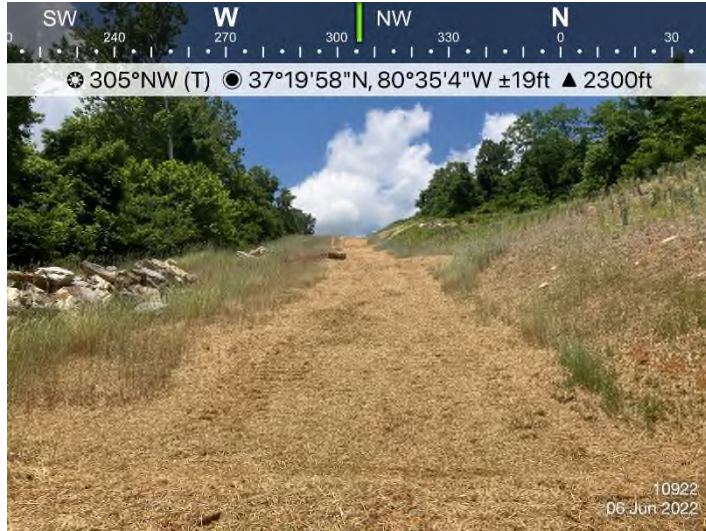
Figure 1: STA 10922+00 – Controls in place and functioning properly. Area stabilized with straw.

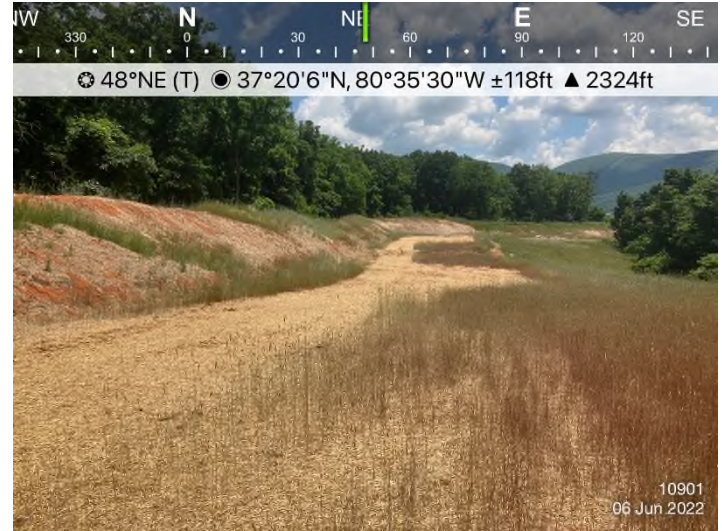
Figure 2: STA 10901+00 – Controls in place and functioning properly. Area stabilized with straw.

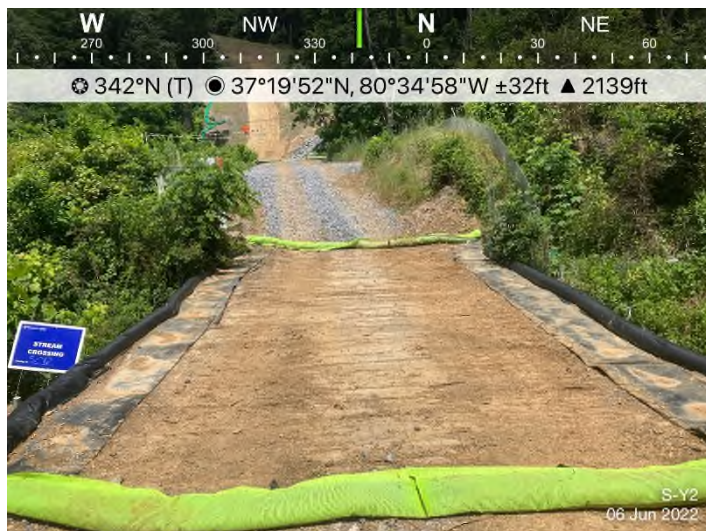
Figure 3: Stream S-Y2 – Controls in place and functioning properly along stream crossing.

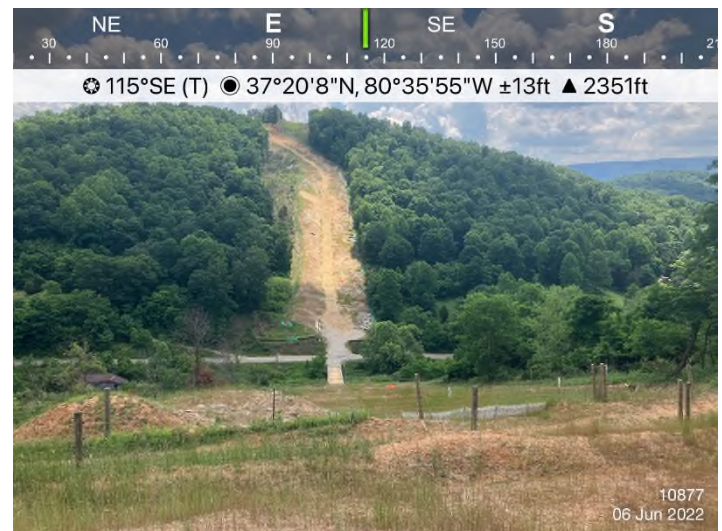
Figure 4: STA 10877+00 – Controls in place and functioning properly.
