Fryingpan Creek, Pigg River, Poplar Branch, Beaverdam Creek TMDL

Technical Advisory Committee Meeting #1

Pre-TMDL meeting

October 7, 2021

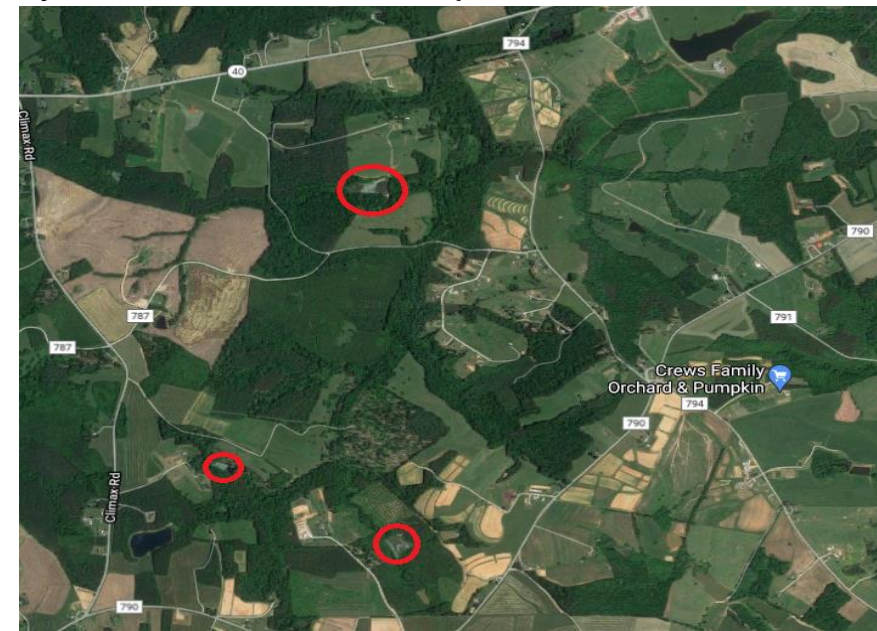
- Several small farm ponds exist on tributaries to Fryingpan Creek that could be altering flow, contributing to influxes of sediment and nutrients or reducing the macroinvertebrate community downstream. Based on the evidence described in Section 4 of the Draft Stressor Identification document, we deemed Hydromodification as a possible stressor.
- Aerial pictures are shown below.

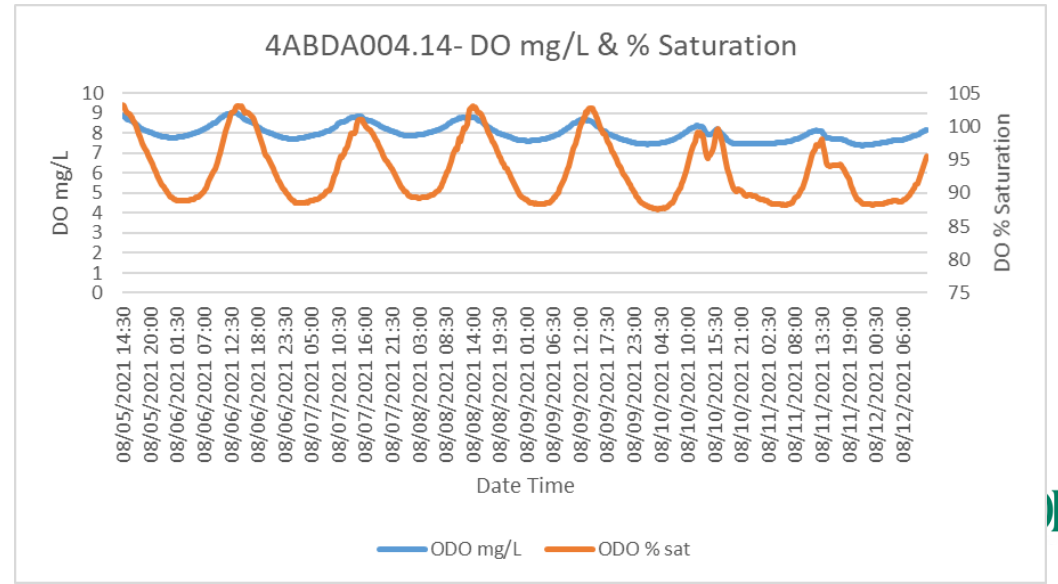
- Total phosphorus was identified as a possible stressor to the Beaverdam Creek benthic community because the median concentration exceeded EPA’s suggested criteria and observations were within the medium probability for stressor category. However, the diurnal DO data did not show extreme daily swings or exceed the water quality standard indicating that there is not a biological effect of the observed excess nutrients at this time.

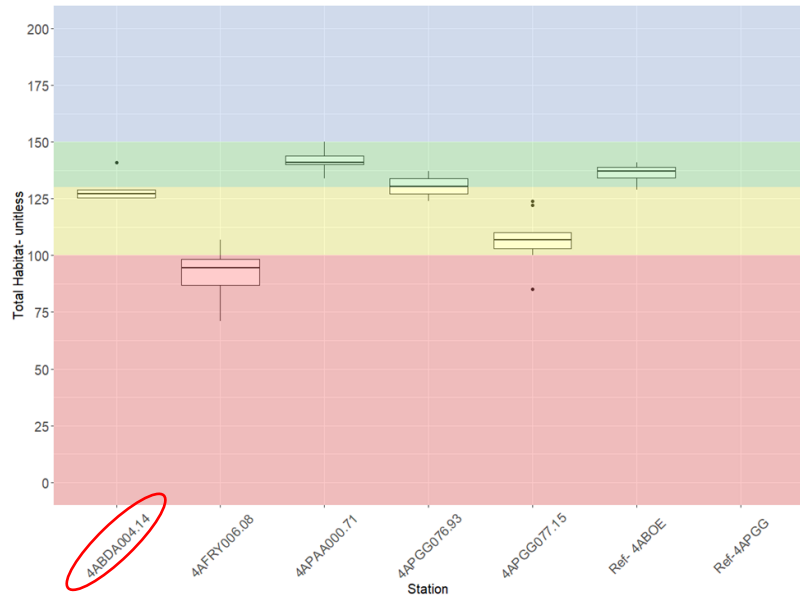
- The median total habitat scores was in the medium probability category for aquatic stress and banks were observed to be unstable with excess sediment observed.
- TSS and Turbidity at Beaverdam spiked during several sampling events.

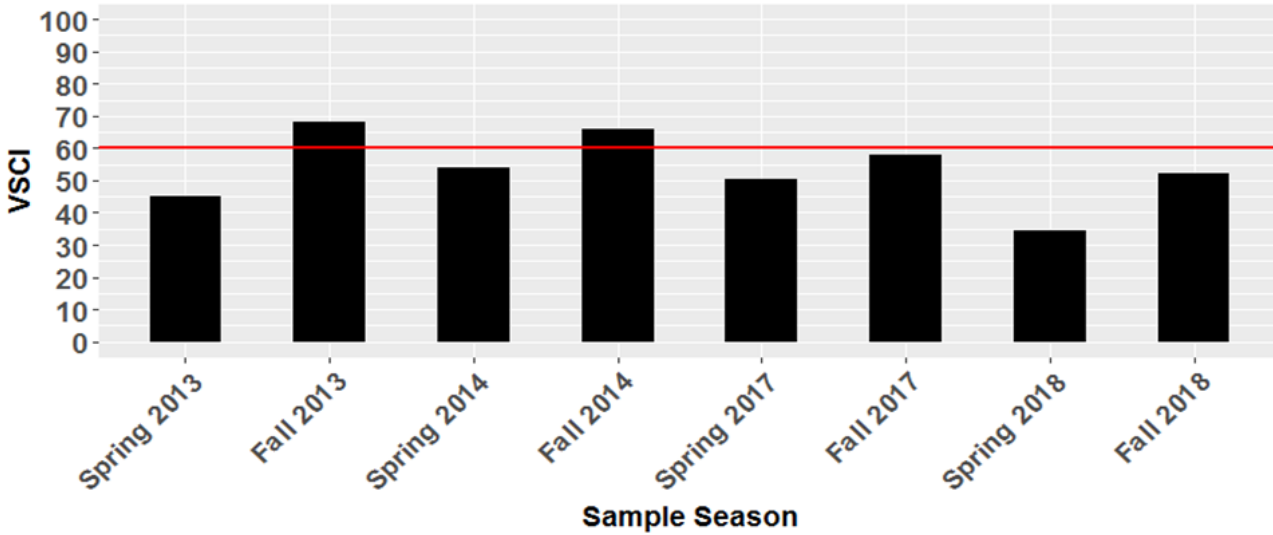
Poplar Branch Macroinvertebrate Data

- Poplar Branch had VSCI scores that were generally higher in the fall than the spring. Two sampling events were over the impairment threshold. The observed seasonal variation is greater than normal.
- The community had very few mayflies and stoneflies.
- The functional feeding group distribution is very similar between Poplar Branch and the reference site.

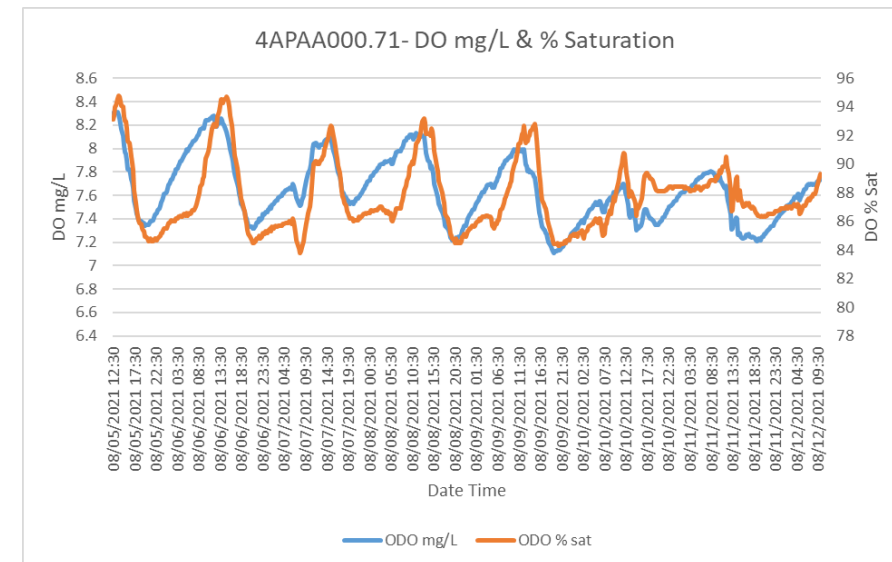
- Total phosphorus was identified as a possible stressor to the Poplar Creek benthic community because the median concentration exceeded EPA’s suggested criteria; however, the median value was within the low probability for stressor category. The diurnal DO data did not show extreme daily swings or exceed the water quality standard indicating that there is not a biological effect of the observed excess nutrients at this time. There was a relationship between elevated TP concentration and low VSCI scores.
