Fryingpan Creek, Pigg River, Poplar Branch and Beaverdam Creek TMDL Project

A water quality study for watersheds in Pittsylvania, Franklin and Bedford Counties

Virginia Department of Environmental Quality

November 18, 2021

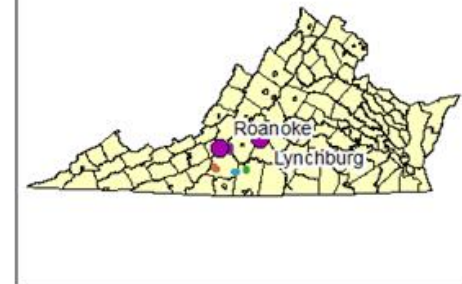
Pigg River, Poplar Branch, Fryingpan Creek, and Beaverdam Creek

- Legend**
- Impaired waters**
- Water Name**
- Beaverdam Creek
 - Fryingpan Creek
 - Pigg River
 - Poplar Branch
 - VAHUC6

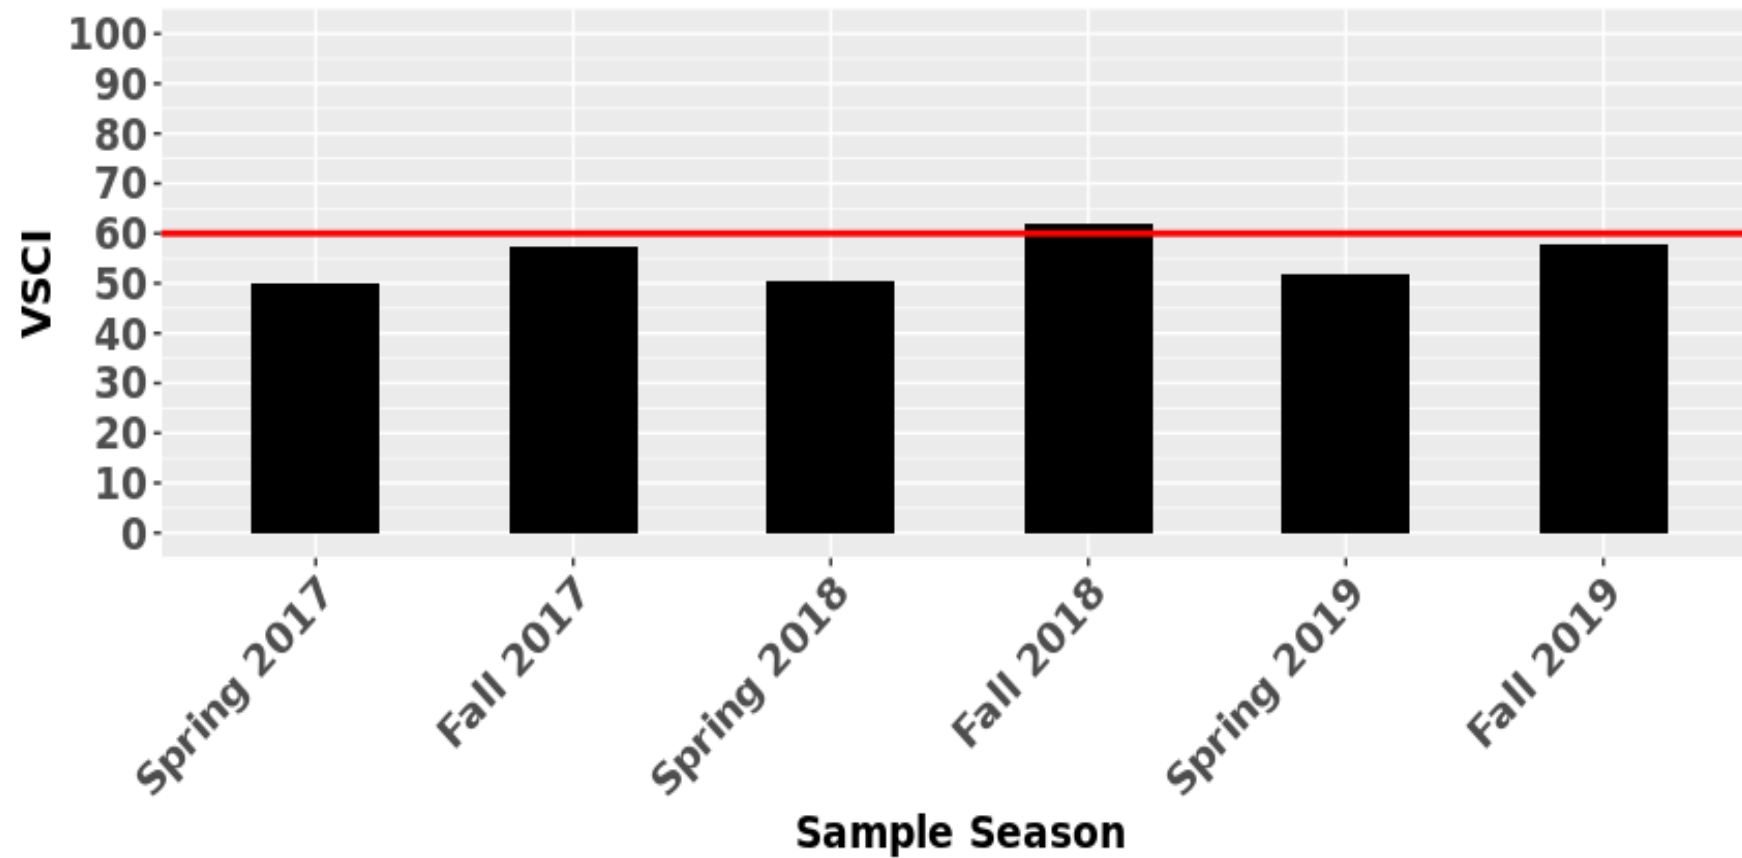
Beaverdam Creek Biomonitoring Data

Low % Mayflies, low % stoneflies and caddisflies, and low % scrapers

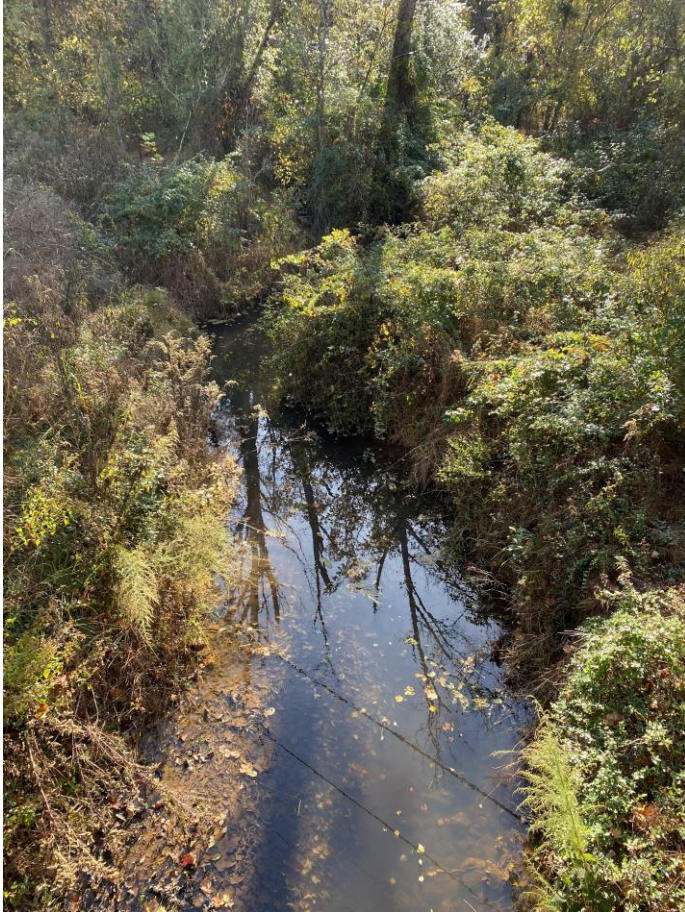
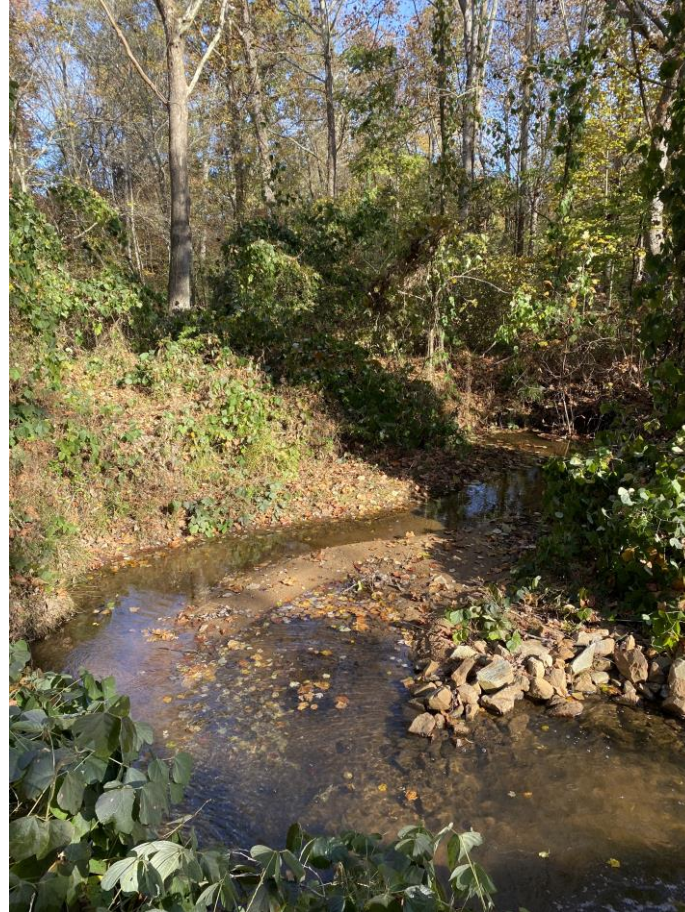
Fryingpan Creek

- Total Habitat Scores were consistently low and driven by excess sediment and unstable banks.

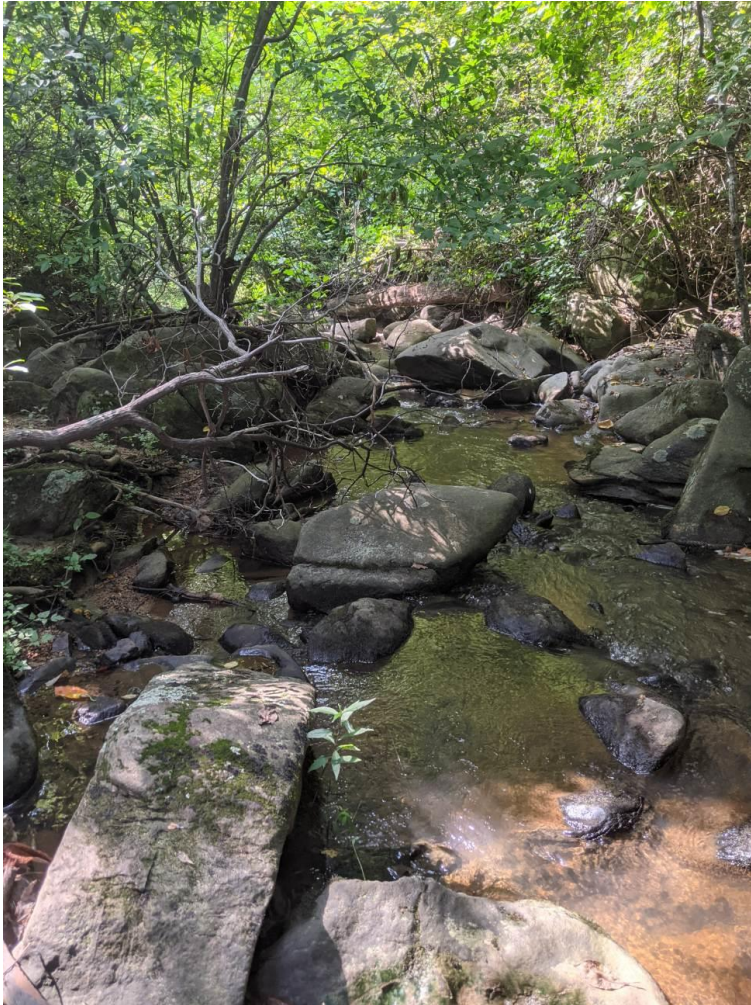
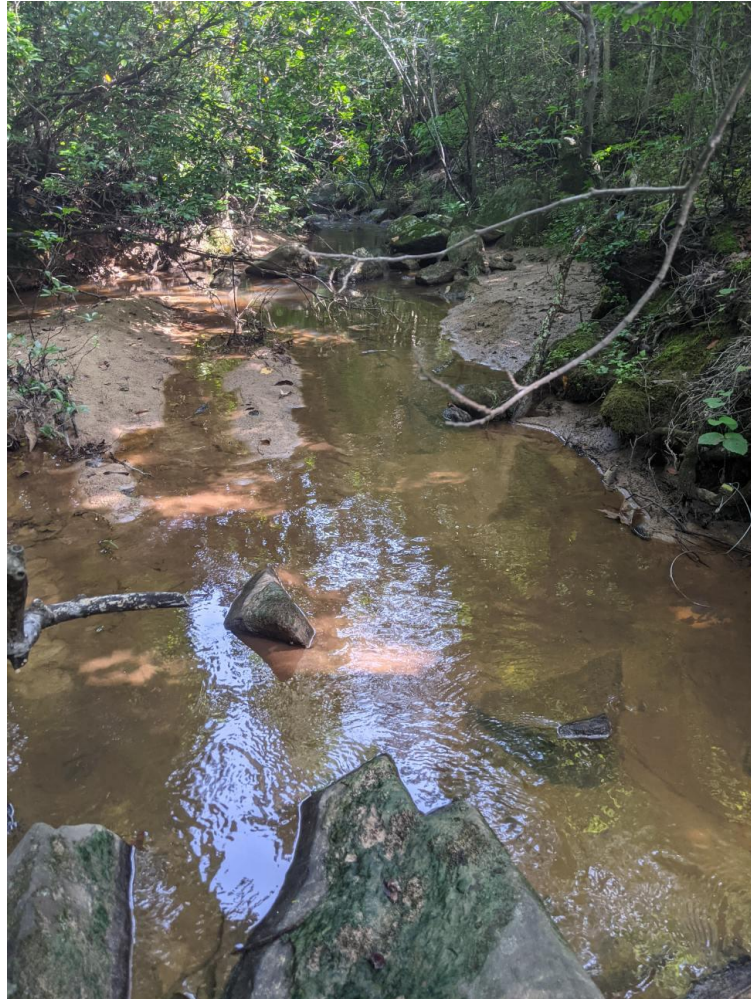
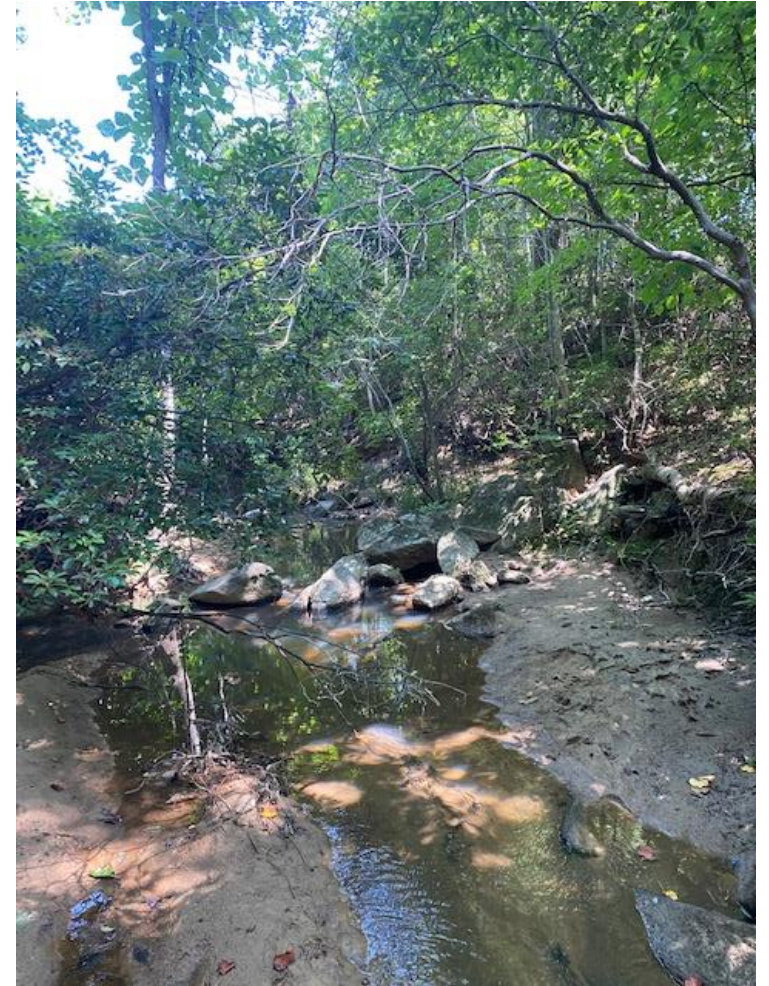
Poplar Branch

- The median total habitat scores was in the medium probability category for aquatic stress and banks were observed to be unstable with little riparian vegetation.

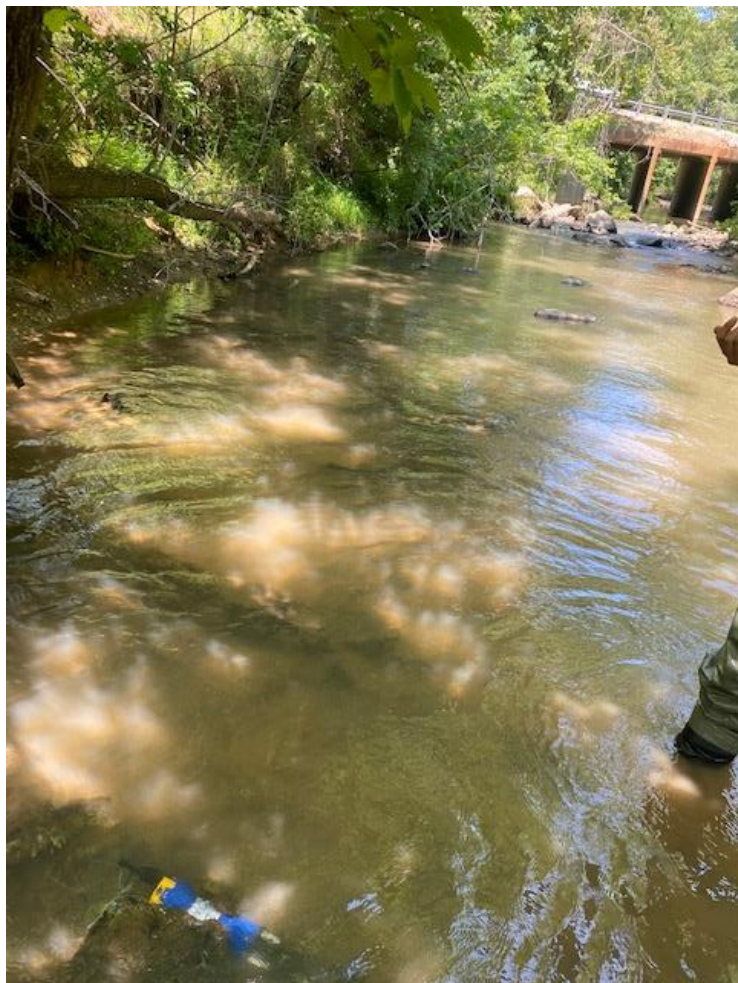
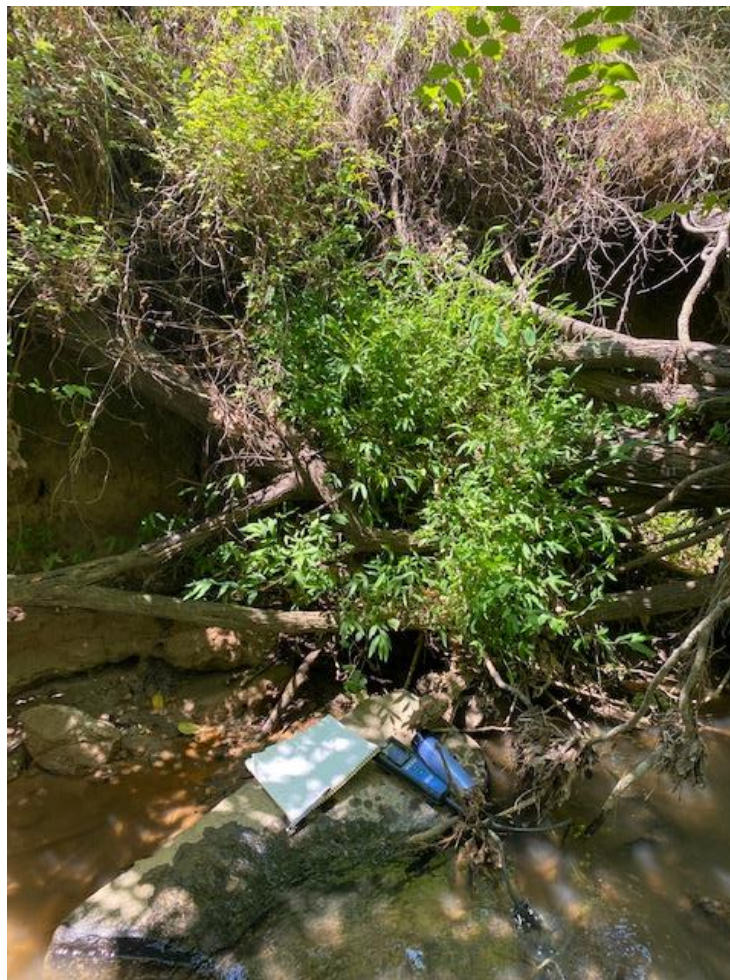
Beaverdam Creek

- The median total habitat scores was in the medium probability category for aquatic stress and banks were observed to be unstable with excess sediment observed.

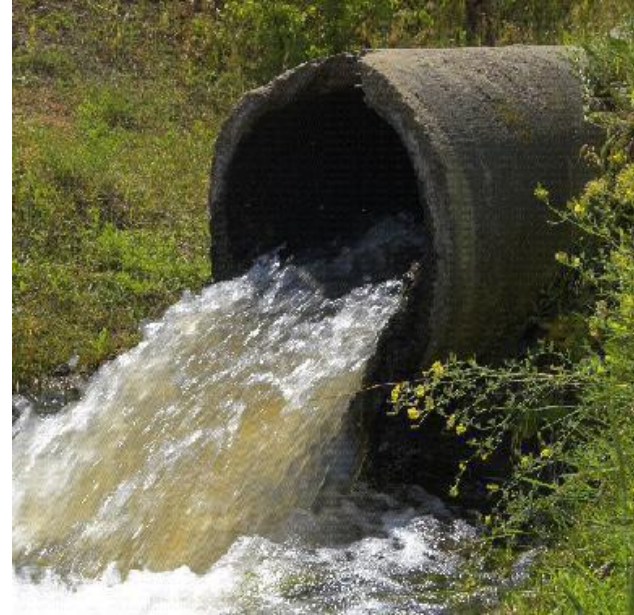
Identify point sources

- Permitted dischargers
- Construction permits

WATERSHED	STREAM	PERMIT NUMBER	PERMIT TYPE	PARAMETERS SAMPLED
BEAVERDAM CREEK	Nat Branch, UT	VA0020842	VPDES IP- municipal	pH, BOD, TSS, Cl ₂ , Ammonia, E. Coli
	Beaverdam Creek	VAG402030	Domestic Sewage	pH, BOD, TSS, DO, Cl ₂
	Nat Branch, UT	VAG402101	Domestic Sewage	pH, BOD, TSS, DO, Cl ₂
