VIRGINIA DEPARTMENT OF  
ENVIRONMENTAL QUALITY

# Fryingpan Creek, Pigg River, Poplar Branch and Beaverdam Creek TMDL Project

A water quality study for watersheds in Pittsylvania, Franklin and Bedford Counties

September 27, 2022

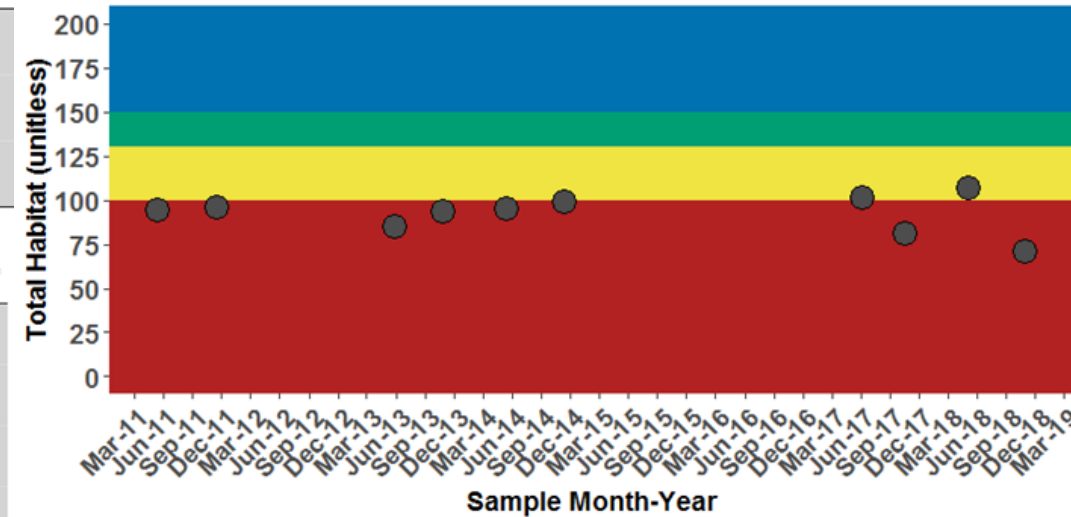
# Fryingpan Creek Stressor Analysis

- Total Habitat Scores were consistently low and driven by excess sediment and unstable banks.

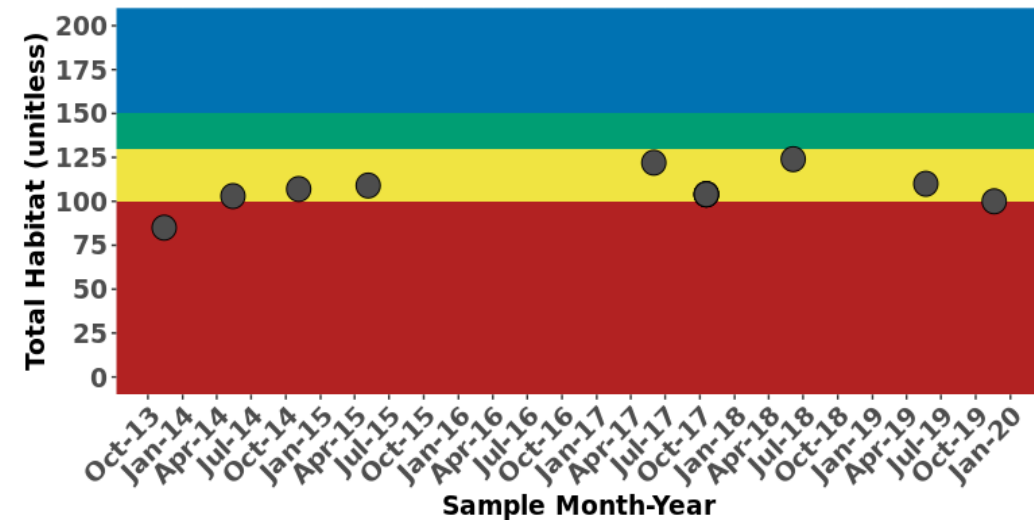
# Pigg River Stressor Analysis

- The median total habitat score was in the medium probability category for aquatic stress and banks were observed to be unstable with little riparian vegetation.
