FIELD INSPECTION REPORT

Project Name:	Mountain Valley Pipeline	Inspector:	Matthew Grant
Inspection Date:	Monday, September 11, 2023	Project Contact:	Brian Clauto
Spread G: Montgomery	AR MN266	Weather:	Wet

FIELD INSPECTION PHOTO LOG

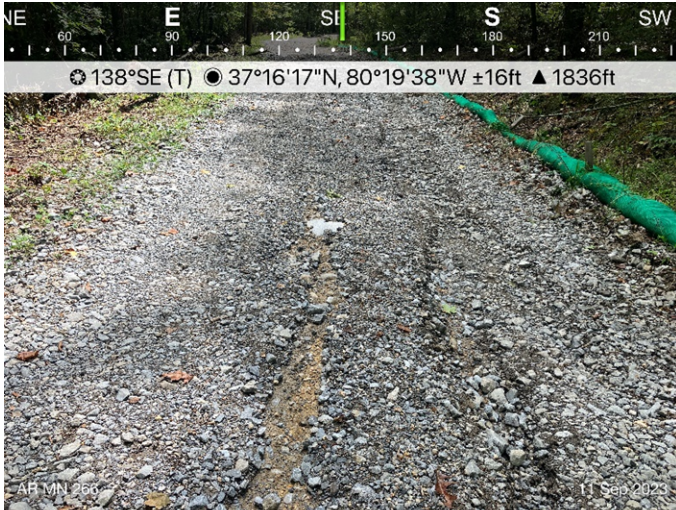
Figure 1: Rill erosion along access road MN 266.

Recommended Corrective Action: Maintain and install all controls per the approved PSS&S.

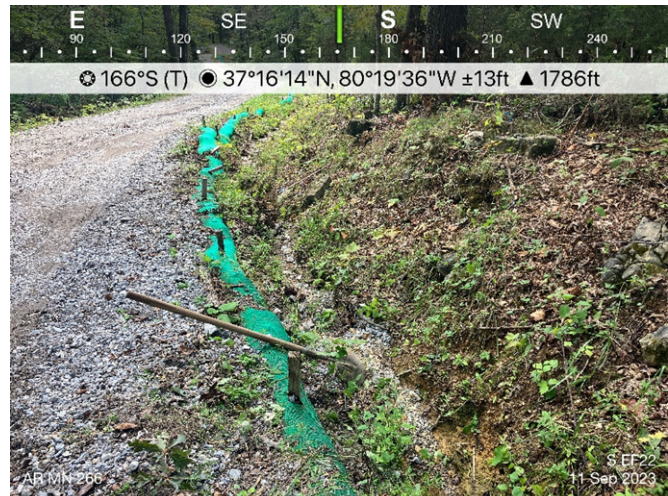
- AR MN 266 requires repair due to rill erosion.
- Multiple areas along AR MN 266 requires CFS maintenance.
- Designated stream S-EF22 was impacted with road gravel approximately 200 feet along AR MN 266 and will require cleaning.

Figure 2: Designated stream S-EF22 along was impacted with gravel.

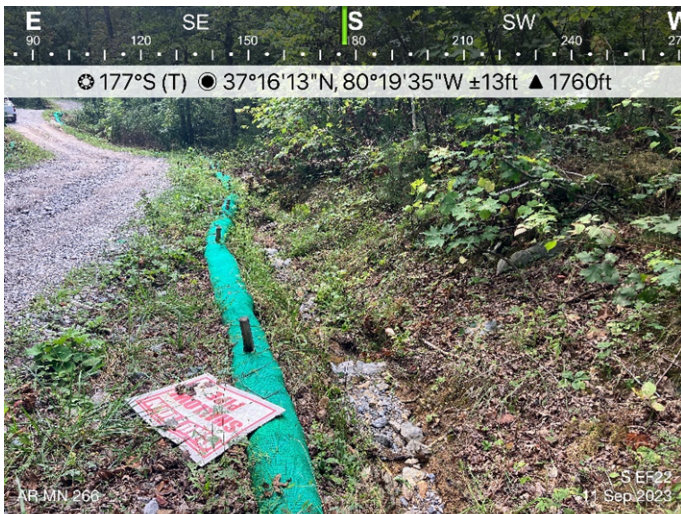
Figure 3: Designated stream S-EF22 along was impacted with gravel.

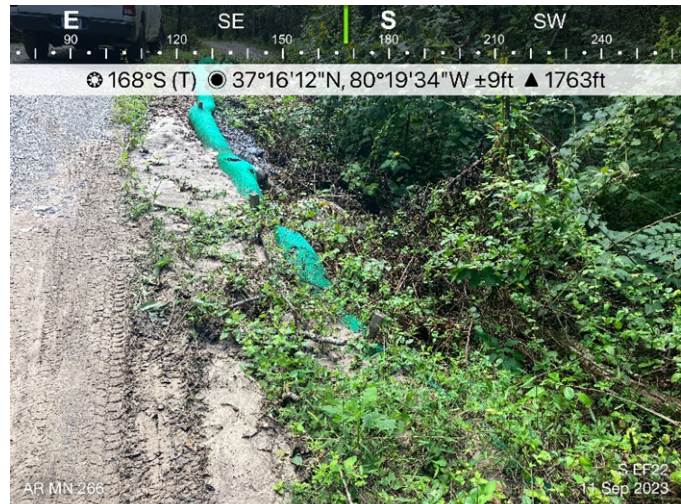
Figure 4: CFS requires cleaning/ maintenance along AR MN 266.
