# HOG ISLAND SHORELINE RESTORATION

*Implementation of a nature-based flood mitigation solution  
for Hog Island to attenuate wave energy and storm surge  
and ultimately improving community resiliency*

# **Hog Island Project Update for the Middle Peninsula Planning District Commission**

# Hog Island Project Summary (as of 8/26/2023)

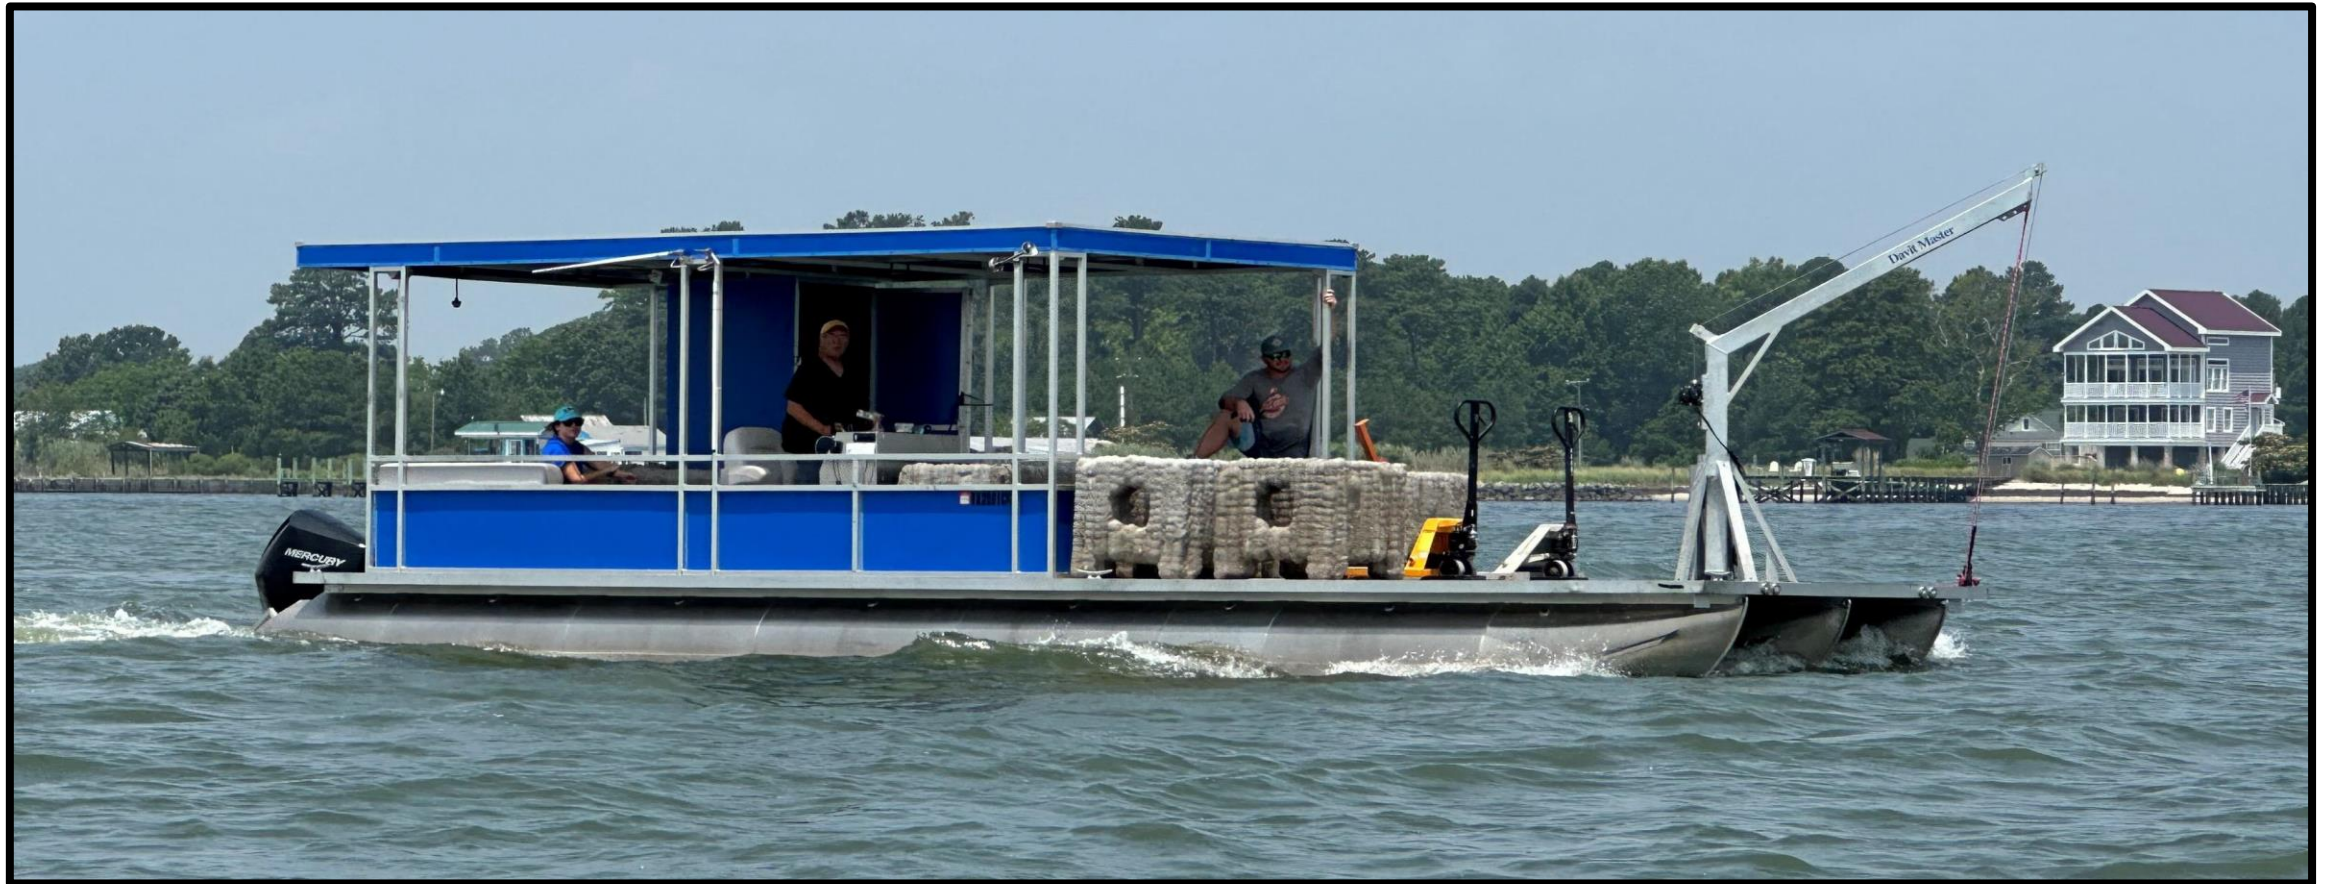
# The Golden Oyster Marine Services Barge

- The same skidsteer was used to move reefs to a designated area adjacent to the GOMS dock
- On deployment days, the GOMS crane truck was moved onto the dock with the GOMS (and/or Seaduce) barge tied up along the dock.

- The crane operator raised each reef individually via a strap and lifting bar, and placed the reef on the barge deck.
- Aboard the barge, a specialty pallet jack was employed to arrange the reefs in a manner that stabilized the load.

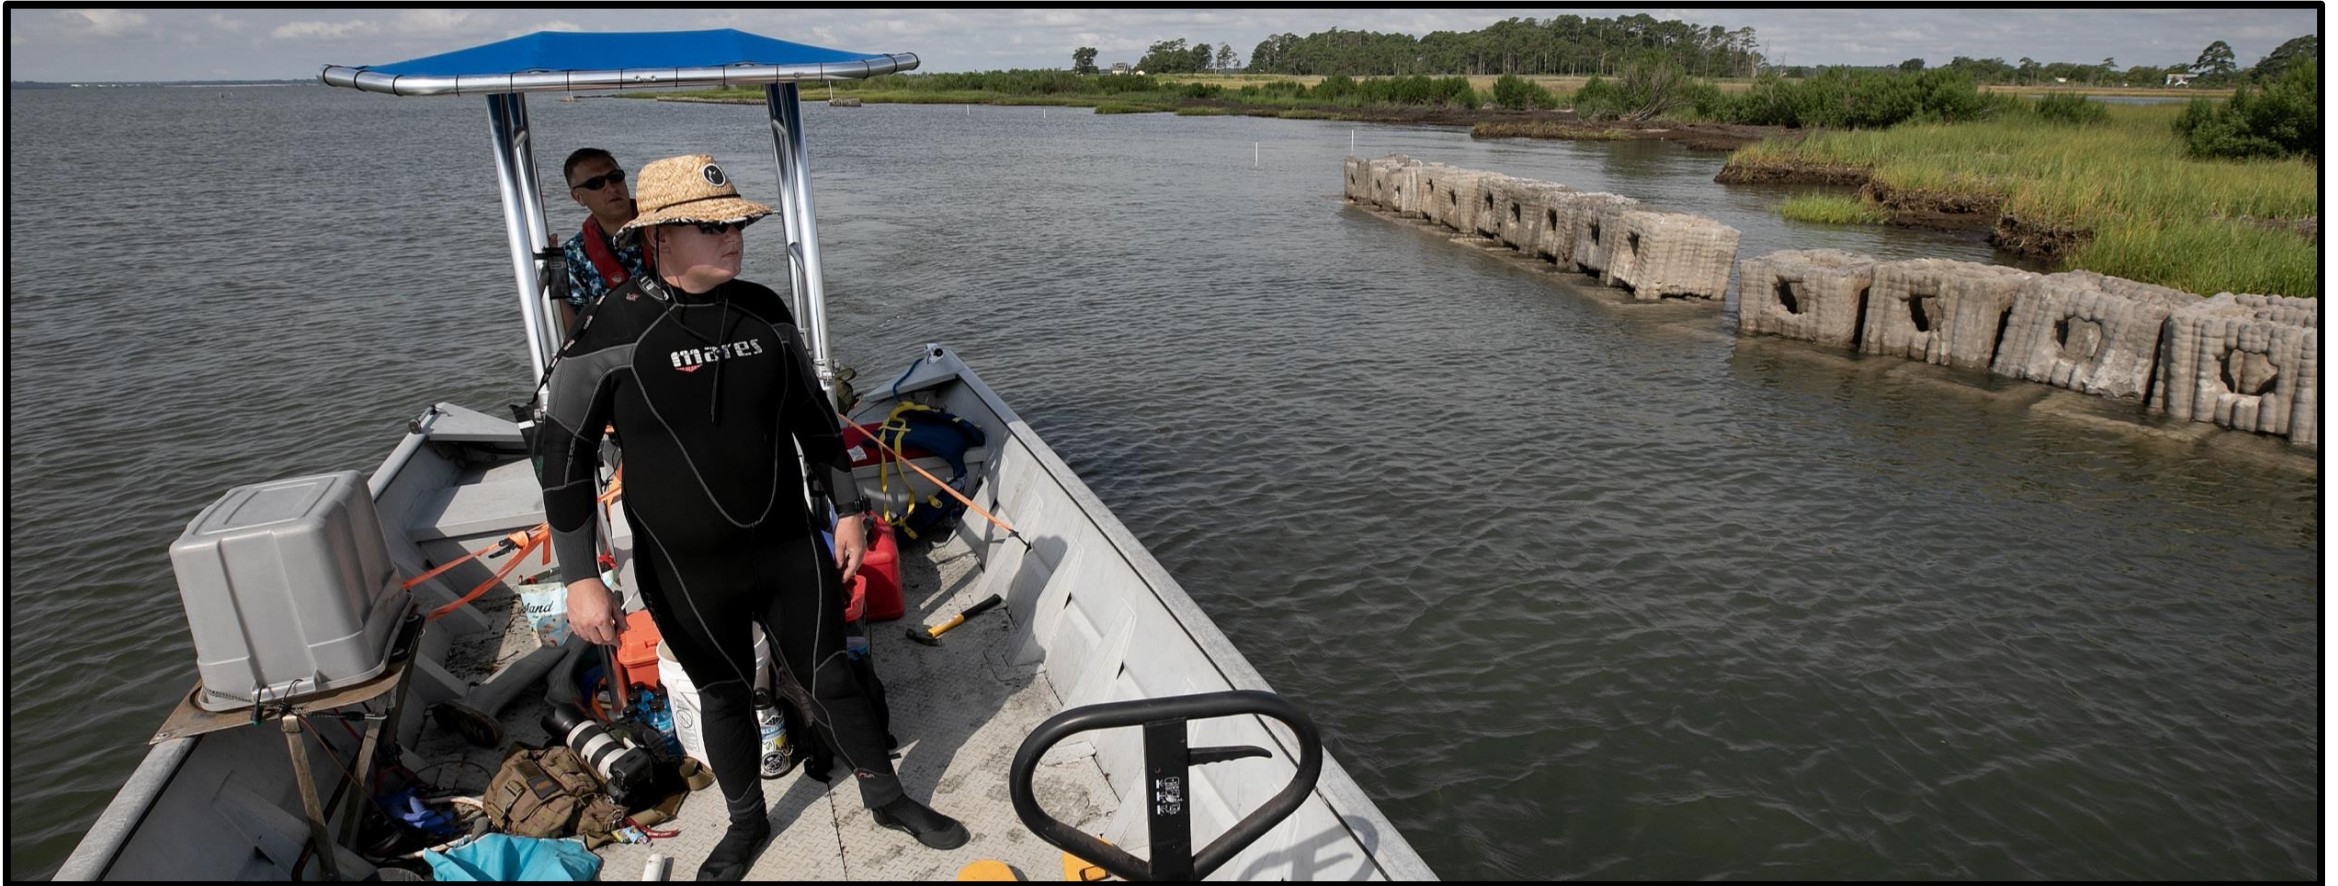
# The Biogenic Solutions Consulting Safety Boat

- Once fully loaded, the barge captain and crew disembarked from the dock and navigated downriver (~2.0 miles) to Hog Island
  - An aluminum johnboat (24 ft long) traveled alongside the barge, serving as a safety vessel in case of emergency and carrying additional gear, including a backup pallet jack

- When the barge and safety boat were within ~0.5 miles of Hog Island, the safety boat proceeded ahead of the barge to ensure that the depth was adequate for safe passage of the fully-loaded barge, as well as to minimize impacts to the seagrass beds located adjacent to the island.

- The safety boat then anchored a safe distance from the intended deployment area and the occupants entered the water to assist the barge with precise positioning on site. Other crew members aboard the barge prepared to anchor/spud and readied the davit and winch for reef deployment.

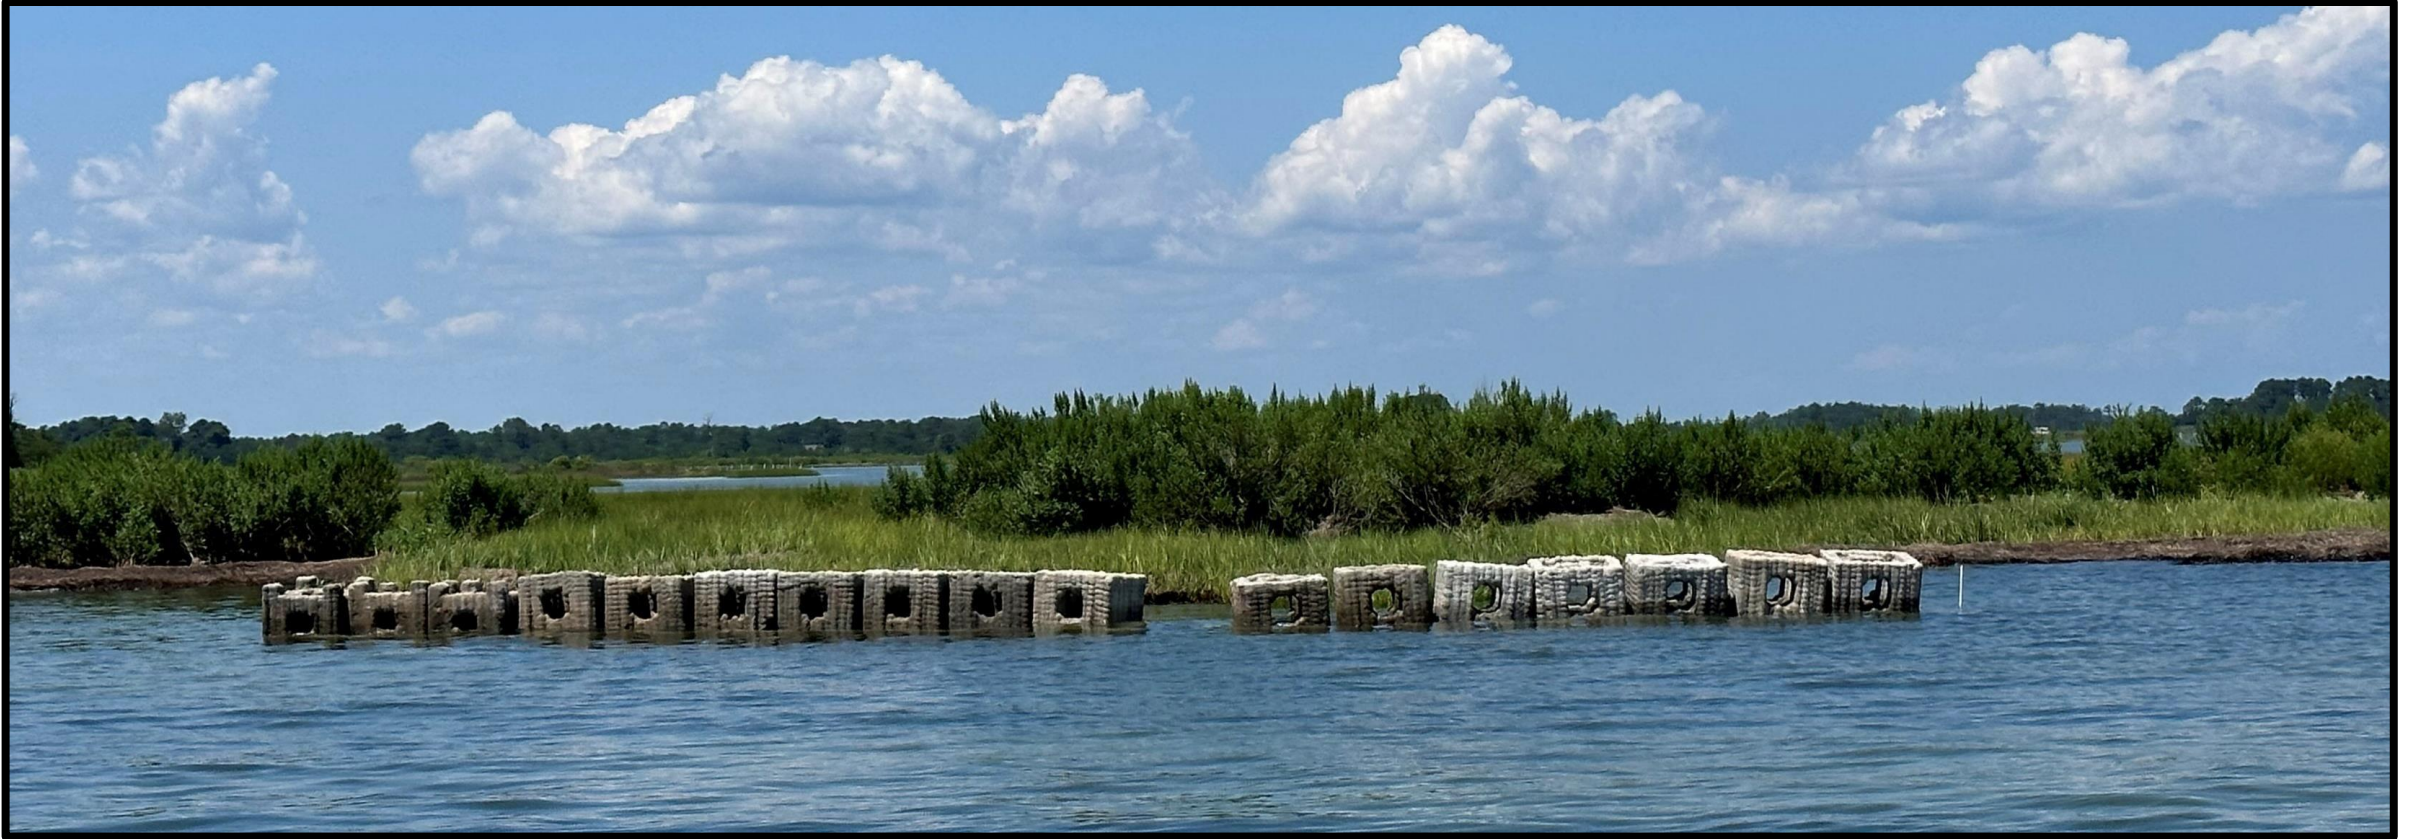
# Structure 10 - NOAA

- 521 (equates to 521 linear feet)
  - Structure 5: Complete
  - Structure 10: Complete (+7 LF NOAA budget amendment funds)
  - Structure 11: Complete
  - Structure 14: Complete

- To enable structures to curve, reefs were either intentionally ended and restarted at a different angle (such as NOAA Reef Structure 10) or slowly arched over the course of many reefs (such as NOAA Reef Structure 11) – the latter was more difficult but became more manageable as the crew's experience grew
