Project/Site: MVP		Citv/C	_{ountv:} Roanoke		Sampling Date: 04/08/2016
Applicant/Owner: MVP				State: VA	Sampling Point: W-AB5
Investigator(s): J. Hart, A.	Larson, T. Woods	Section			<u></u>
Landform (hillslope, terrace, e			-		Slone (9/.): 0
Subregion (LRR or MLRA): L

Project/Site: MVP	City/County: Ro	oanoke	Sampling Date: 04/08/2016
Applicant/Owner: MVP		State: VA	Sampling Point: W-AB5-UP
Investigator(s): J. Hart, A. Larson, T. Wood	ds Section, Townsl		
Landform (hillslope, terrace, etc.): Terrace		-	Slope (%): 0
Subregion (LRR or MLRA): LRR N			
Soil Map Unit Name: 16B - Edneyville fine sa			
Are climatic / hydrologic conditions on the site typ			
Are Vegetation, Soil, or Hydrology		Are "Normal Circumstances	" present? Yes No
Are Vegetation, Soil, or Hydrology	naturally problematic?	(If needed, explain any answ	wers in Remarks.)
SUMMARY OF FINDINGS – Attach si	te map showing sampling p	oint locations, transec	ts, important features, etc.
Hydrophytic Vegetation Present? Yes _	No Is the Sc		
	No V	Impled Area	No
Wetland Hydrology Present? Yes _	No Within a	Wetland? Yes	NO
Remarks: Cowardin Code: UPLAND		/ater Type:	
Upland plot occurs on slightly higher te		* *	Paired plot with b

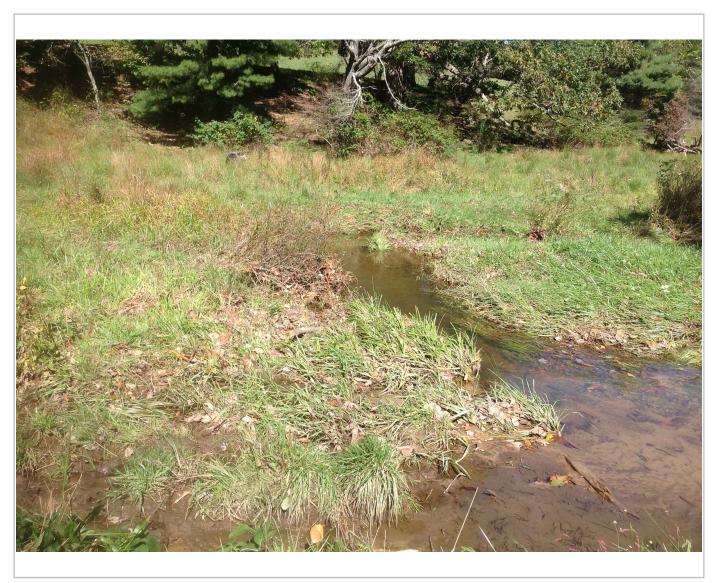
Photograph Direction North

Layer (if observed):									
Type: Re	efusal, gravel									
Depth (inc	ches): <u>6</u>						Hydric Soil	Present?	Yes 🗸	No
Remarks:							I.			
Disturbed s	soils in pasture.
