## **COMPLAINT INSPECTION REPORT**

| Project Name: | Mountain Valley Pipeline | Inspector: | John McCutcheon |

| STAGE OF CONSTRUCTION: (Check all that apply) | |
|---|---|
| Comments: This report is for an inspection at Brick Church Road Crossing near MP 261.75. | |

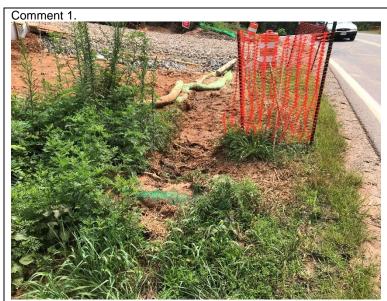
| STAGE OF CONSTRUCTION: (Check all that apply) | |
|---|---|
| Compost filter socks check dams in roadside full of sediment. | |

Compost filter socks check dams in roadside full of sediment

| Comment # | Regulatory<br>Citation/Legal<br>requirement <sup>1</sup> | Observation/Recommended Corrective Action |
|---|--|---|
| 1 | (Va. Code §62.1-<br>44.15:31) (MVP<br>Standards &<br>Specifications for VA,<br>p. 1) (9VAC 25-840-<br>60.A). | Observation: Compost filter socks check dams in roadside full of sediment. Recommended Corrective Action: Clean out accumulated sediment in filter sock check dams and roadside ditch. |

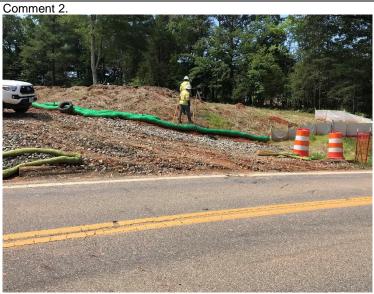
| STAGE OF CONSTRUCTION: (Check all that apply) | |
|---|---|
| 2. Stone construction entrance on north side of Brick Church Road clogged with mud. | |

Stone construction entrance on north side of Brick Church Road clogged with mud

| Comment # | Regulatory<br>Citation/Legal<br>requirement <sup>1</sup> | Observation/Recommended Corrective Action |
|---|--|---|
| 2 | (Va. Code §62.1-<br>44.15:31) (MVP<br>Standards &<br>Specifications for VA,<br>p. 1) (9VAC 25-840-<br>60.A). | Observation: Stone construction entrance on north side of Brick Church Road clogged with mud. Recommended Corrective Action: Maintain construction entrance with clean stone. |
