FIELD INSPECTION

Project Name:	Mountain Valley Pipeline	Inspector:	Matthew Grant
Inspection Date:	Thursday, December 20, 2018	Project Contact:	Brian Clauto
Spread: Giles County AR GI 234 Designated stream SQ14	Spread G	Weather (Wet/Dry/Rain):	Wet

FIELD INSPECTION PHOTO LOG

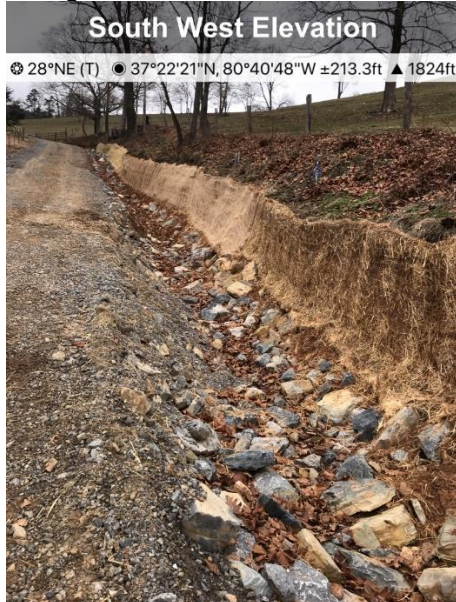
- Access Road GI 234 rock lined channel appears to be functioning; vertical cut ditch walls have had matting installed. Designated stream SQ14 shows signs of sediment and possibly road gravel in the stream.

- Fig. 1 AR GI 234 rock lined channel ditch have been matted.

Recommended Corrective Action: Submit amended plans for GI 234 access road to DEQ for approval; remove sediment and road gravel on SQ 14 per property owner approval.

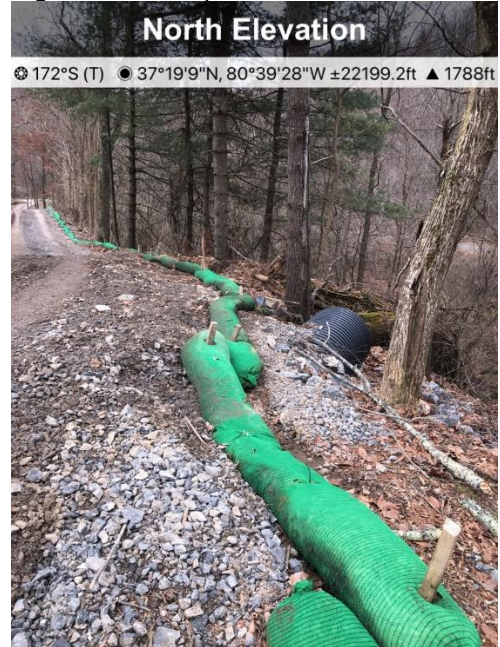
- Fig. 2 ECD's in place on AR GI 234
