FIELD INSPECTION REPORT

Project Name:	Mountain Valley Pipeline	Inspector:	Matthew Grant
Inspection Date:	Wednesday, March 31, 2021	Project Contact:	Brian Clauto
Spread H: Roanoke	AR RO 286 AR RO 287 ATWS 1225, 1305, 1306 St12955-12959	Weather:	Rainy

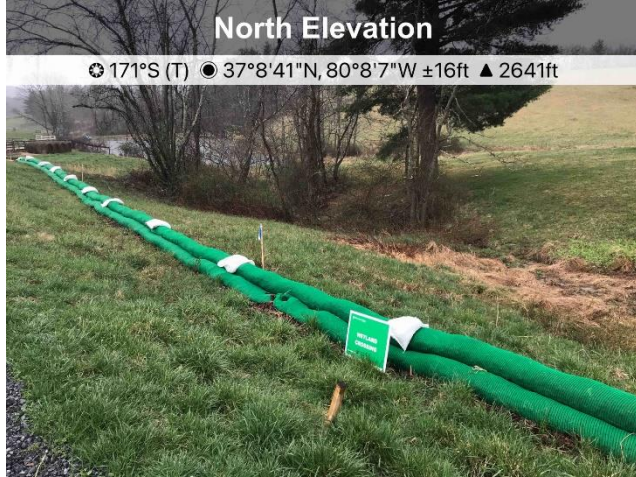
- Comments: Inspected the following resources: S-Z16, W-Z6, W-Z8, S-Z17, W-Z9, S-Y7, S-Y8, W-Y2, W-Y1, W-CD9
- ECD's were in place and functioning at the designated crossing.

Figure 1: Protected wetland W-CD9 remains undisturbed.

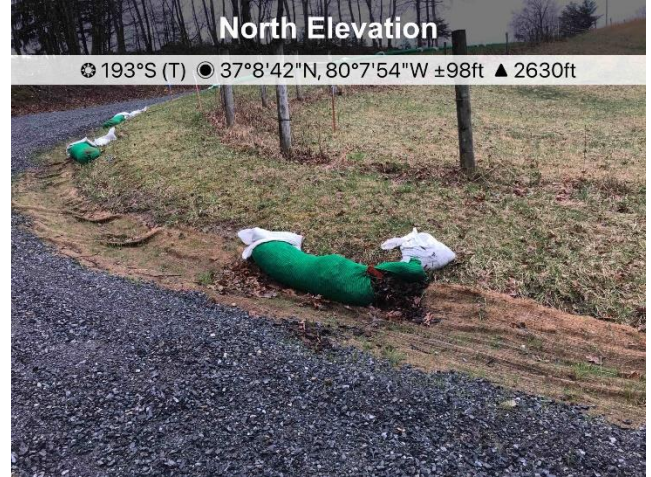
- AR RO287 bank is denuded along access road and requires stabilization.
- AR RO286 two CFS require maintenance along access road.

Figure 2: CFS maintenance required along AR RO 286.

Recommended Corrective Action: Maintain and install all controls per the approved PSS&S.

Deadline: Within 72-Hour of Notification

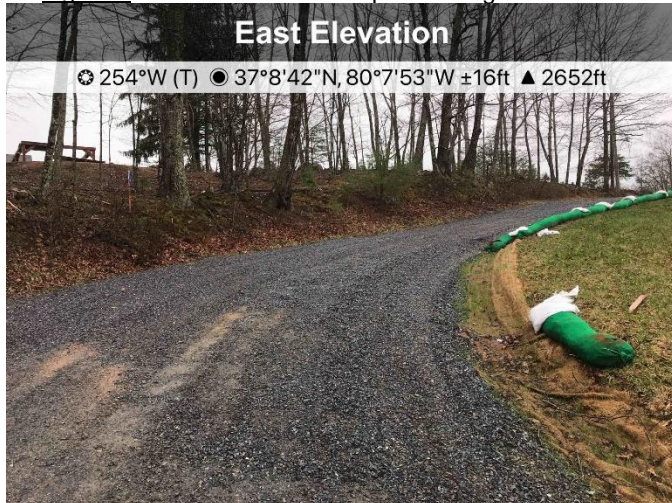
Figure 3: CFS maintenance required along AR RO 286.

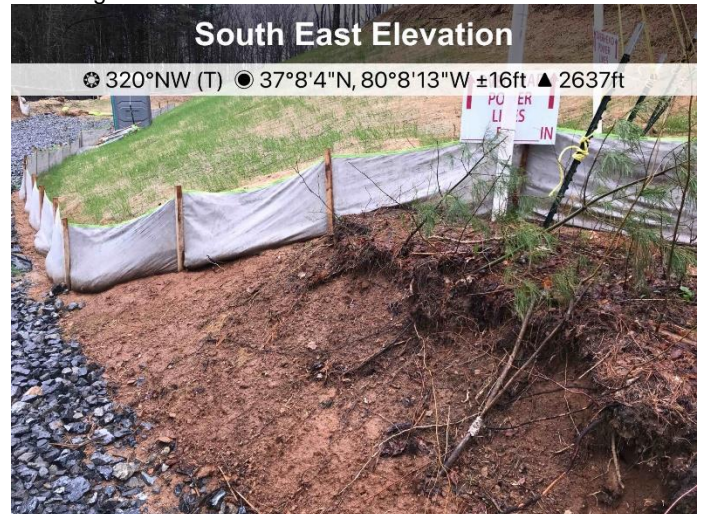
Figure 4: Additional stabilization requires on denuded slope along AR RO 287.
