FIELD INSPECTION REPORT

Project Name:	Mountain Valley Pipeline	Inspector:	Matthew Grant
Inspection Date:	Tuesday, April 13, 2021	Project Contact:	Brian Clauto
Spread G: Craig Giles	ST11524-11470 AR 258.02	Weather:	Dry

FIELD INSPECTION PHOTO LOG

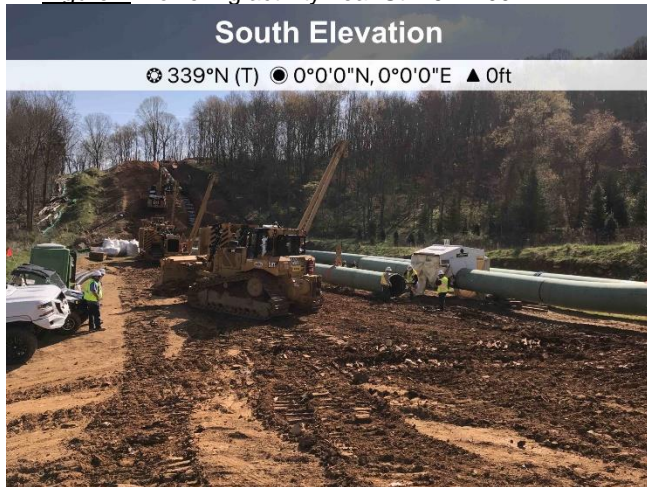
Figure 1: Lowering activity near St11524+00.

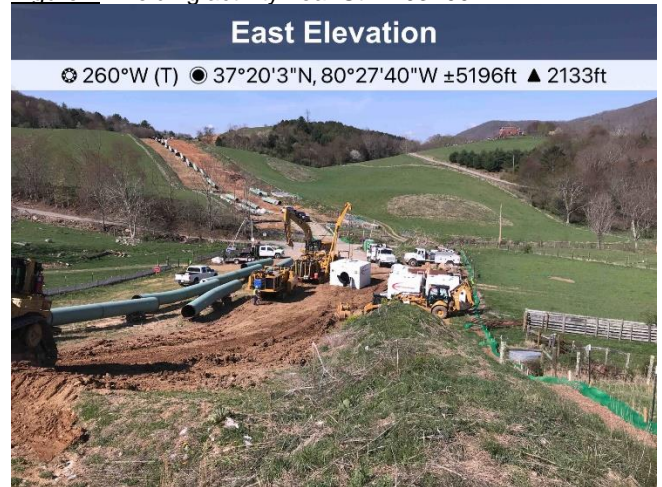
Figure 2: Welding activity near St11493+00.

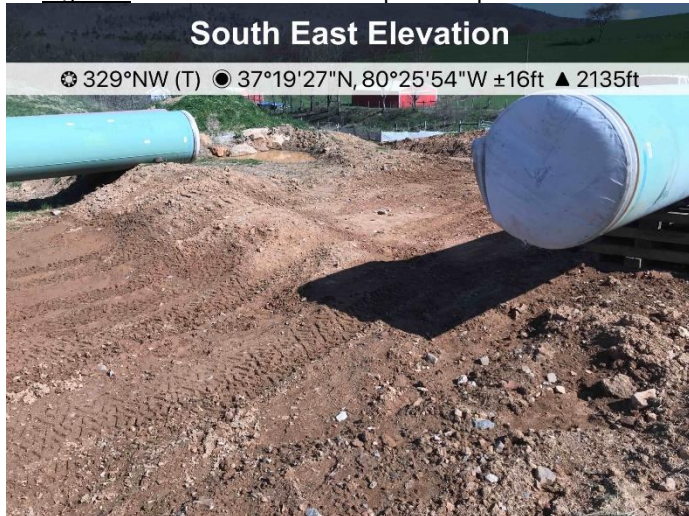
- St11488+00 waterbar is does not run the length of the ROW and does not meet the standard and spec.

Figure 3: Waterbar not installed per the spec at St11488+00

Recommended Corrective Action: Maintain and install all controls per the approved PSS&S.

Deadline: Within 24-Hour of Notification

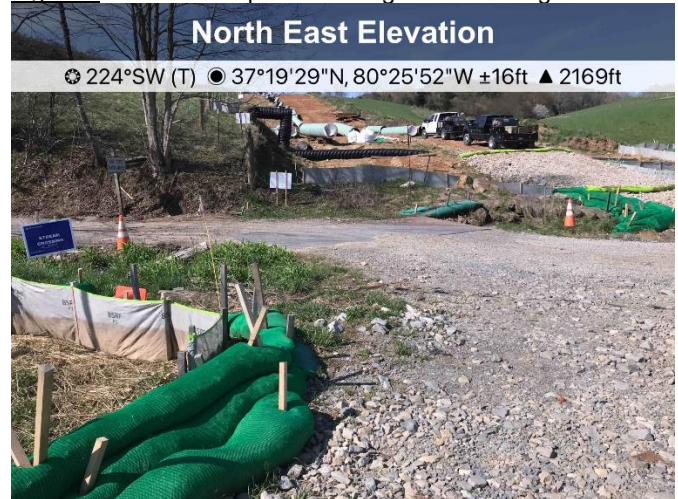
- Comments: Inspected the following resources: S-QQ2, S-PP4, S-PP3, S-PP1
- ECD's were in place at designated crossing per active construction.

Figure 4: ECD's are in place at designated crossing S-PP1.
