## FIELD INSPECTION

<b>Project Name:</b>	Mountain Valley Pipeline	<b>Inspector:</b>	Matthew Grant
<b>Inspection Date:</b>	Wednesday, October 10, 2018	<b>Project Contact:</b>	Brian Clauto
<b>Spread: Montgomery County MP 226 St#11933-11965</b>	Spread G	<b>Weather (Wet/Dry/Rain):</b>	Wet

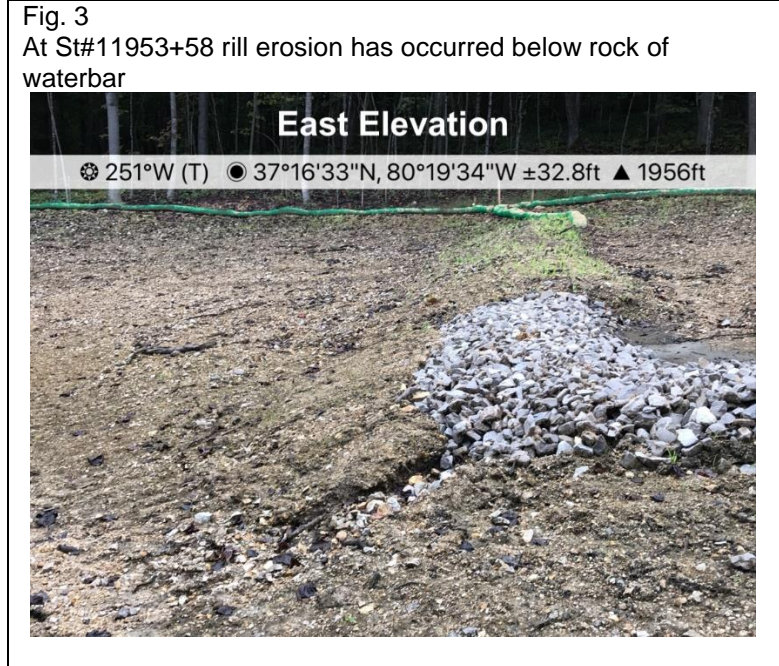
- **Area 1** –MP 226 St#11952+58 through St#11953+88 erosion has occurred below rock of waterbars repair and re install per the spec MVP17.7
