**Mountain Valley Pipeline, LLC  
Mountain Valley Pipeline Project  
Docket No. CP16-10-000**

**Implementation Plan  
Dated October 2017**

**Attachment IP-20**

# KARST MITIGATION PLAN

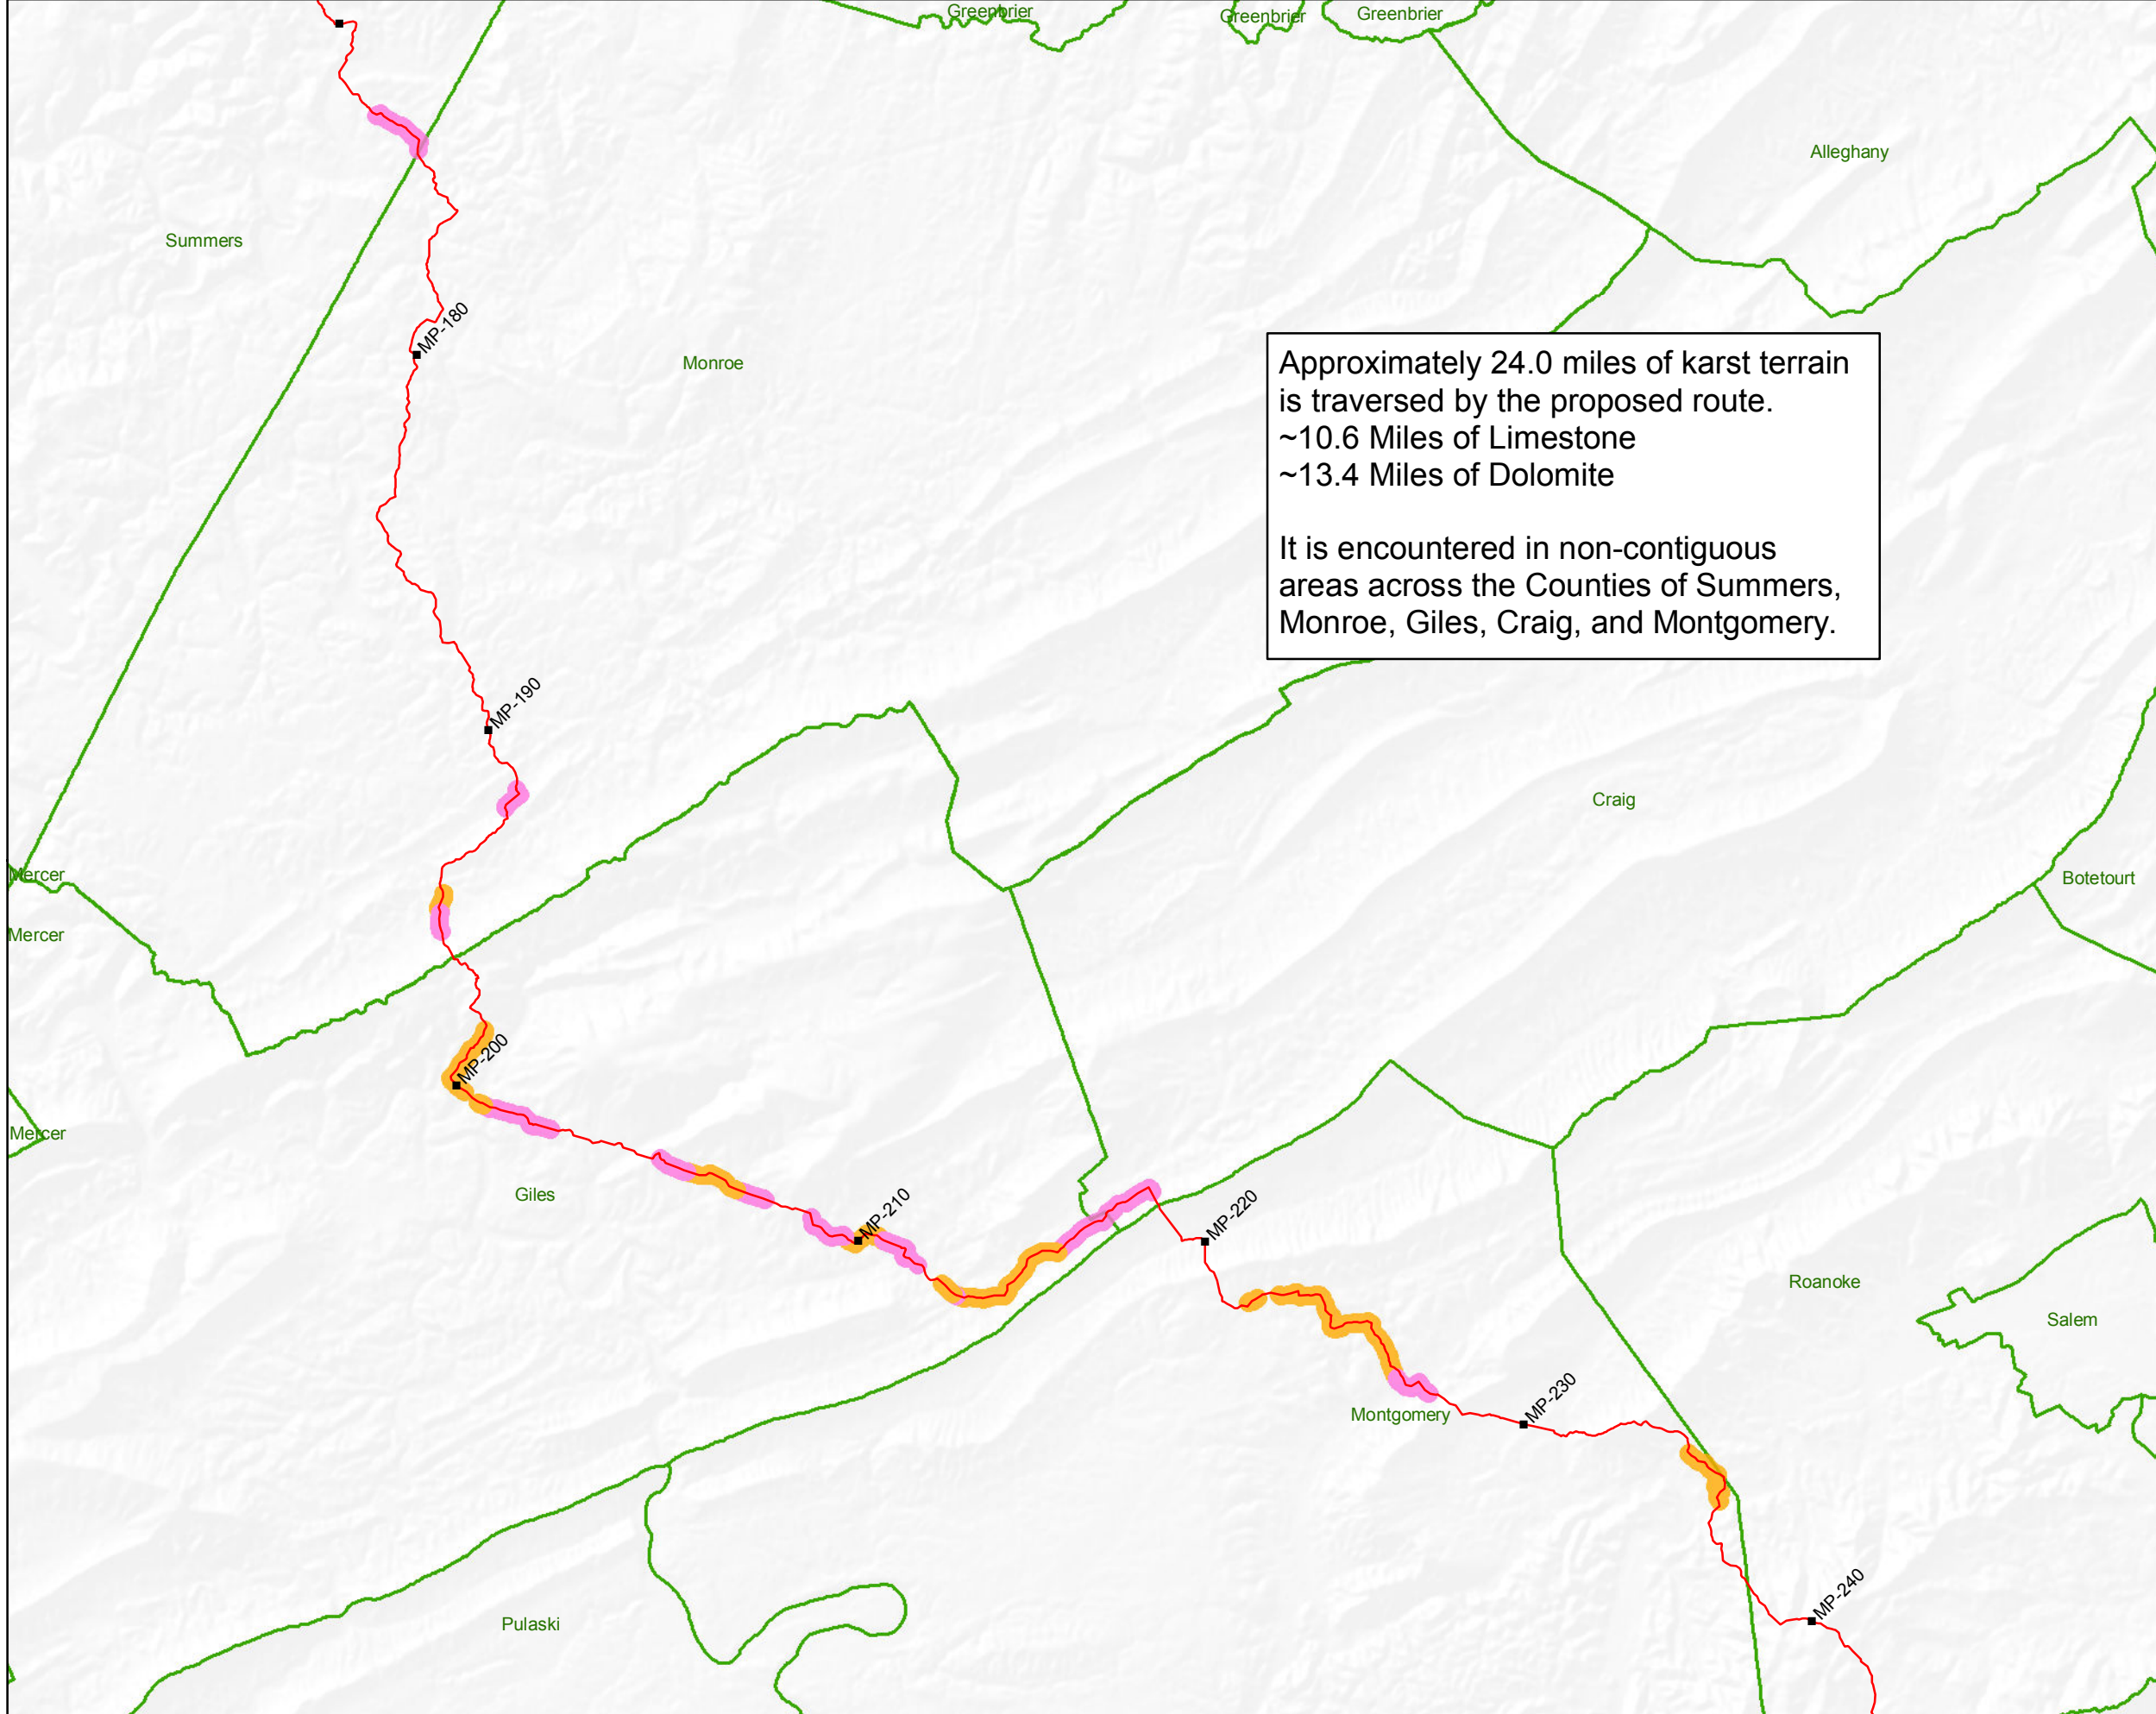
**FIGURE 1 – KARST ZONE .....19**

Approximately 24.0 miles of karst terrain  
is traversed by the proposed route.  
~10.6 Miles of Limestone  
~13.4 Miles of Dolomite

It is encountered in non-contiguous  
areas across the Counties of Summers,  
Monroe, Giles, Craig, and Montgomery.

The most prevalent type of karst feature observed at the ground surface along the proposed MVP alignment in karst terrain (**Figure 1**) are sinkholes. Sinkholes fall into two broad categories, termed “vault-collapse” sinkholes, or “cover-collapse” sinkholes. Vault-collapse type sinkholes (i.e., where a cavern “vault” or roof has failed catastrophically) are relatively rare in karst terrain along the proposed MVP alignment. However, cover-collapse type sinkholes are more commonly observed.
