## COMPLAINT INSPECTION REPORT

<b>Project Name:</b>	Mountain Valley Pipeline	<b>Inspector:</b>	John McCutcheon
<b>Inspection Date:</b>	Tuesday, August 14, 2018	<b>Project Contact:</b>	Brian Clauto, Tim Bowen
<b>Spread:</b>	Spread G	<b>Weather (Wet/Dry/Rain):</b>	Dry

## FIELD INSPECTION PHOTO LOG

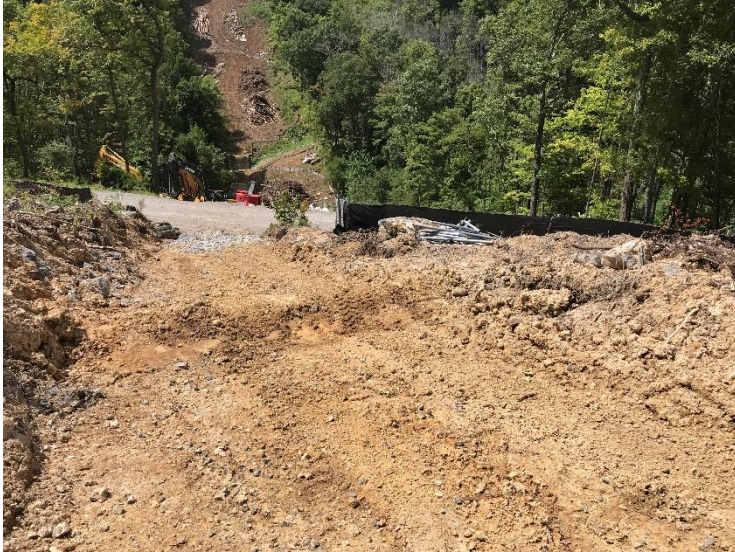
Comment 1.

1. Silt fence and rough waterbars used on areas cleared but not graded appear to be recently maintained and in fair condition.
2. Timber bridges at stream crossings S-A34 and S-A33 in good condition.
3. No sediment deposits observed in stream channels and no fuel spill or odor detected.
4. Construction entrance on east side of Kow Camp Road needs additional stone to a length of 70 ft.

Temporary waterbar in fair condition.

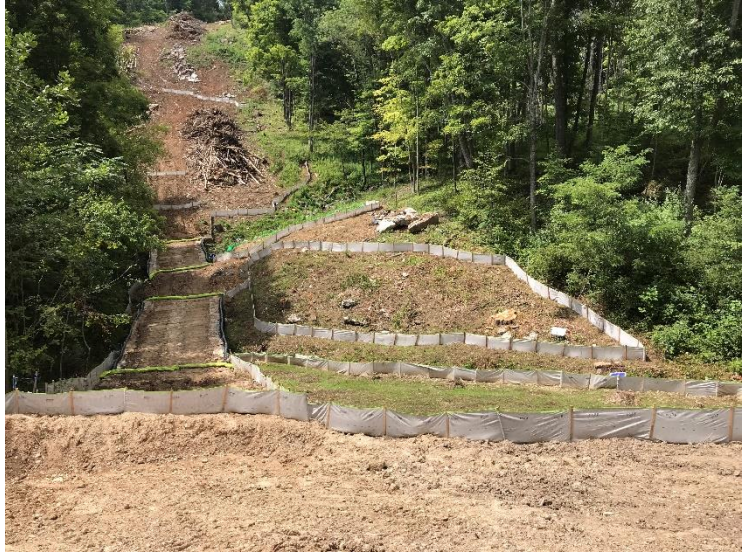
Comment 2.

Timber bridges and other E&S controls in good condition.

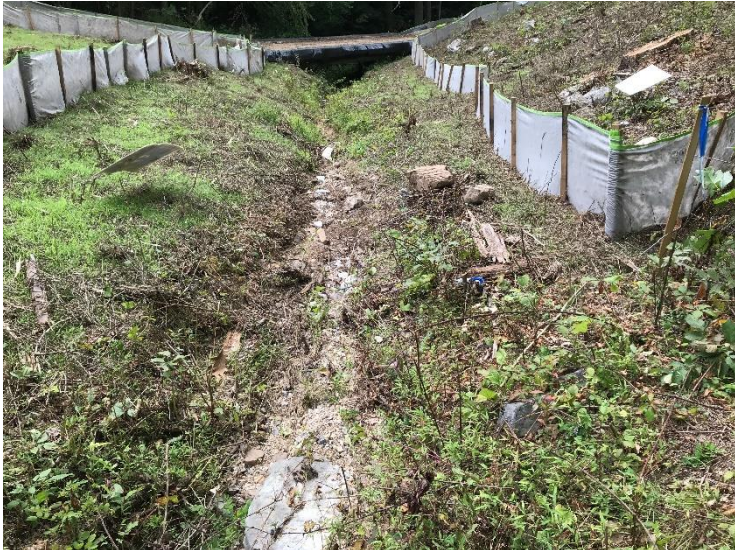
Comment 3.

Channel clear of sediment deposits.

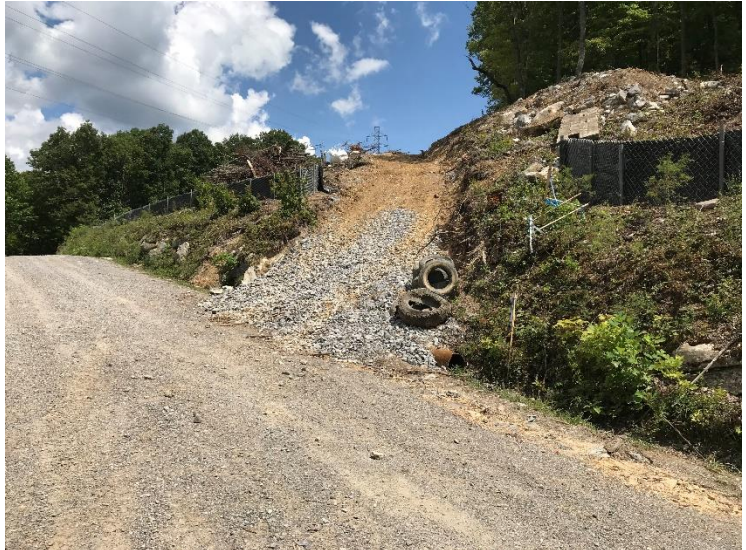
Comment 4.

Comment #	Regulatory Citation/Legal requirement <sup>1</sup>	Observation/Recommended Corrective Action
4	(Va. Code §62.1-44.15:31) (MVP Standards & Specifications for VA, p. 1) (9VAC 25-840-60.A).	<p><b>Observation</b> Stone construction entrance appears less than 70 ft. in length</p> <p><b><u>Recommended Corrective Action:</u></b> <i>Maintain entrance with application of additional stone to specified length.</i></p>

Stone construction entrance.

Recommended Corrective Action Deadline: Within 24 Hours of notice
